# YOUR INSPECTION REPORT

123 Main St  
Oregon, OR

Monday, February 3, 2020

RE: Report No. 1127  
123 Main St  
Oregon, OR

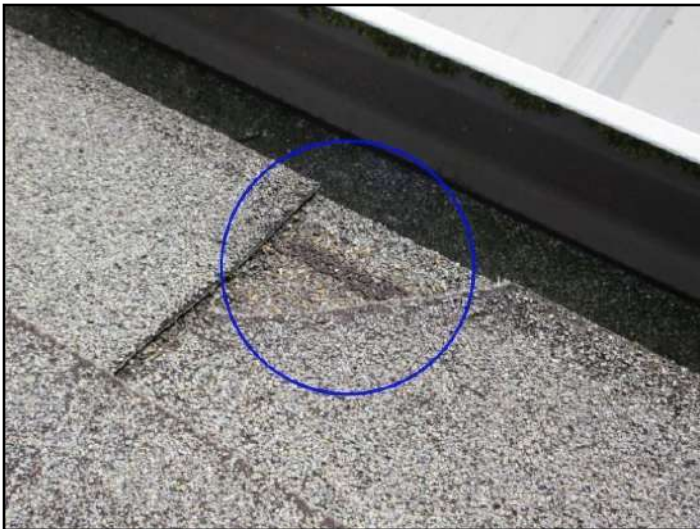
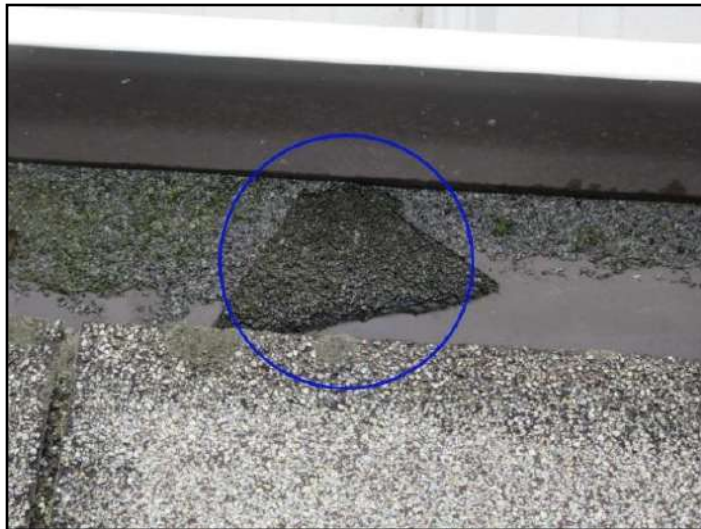
## 2. Condition: • [Missing, loose or torn](#)

**Implication(s):** Chance of water damage to contents, finishes and/or structure

**Location:** South Roof

**Task:** Further evaluation Monitor

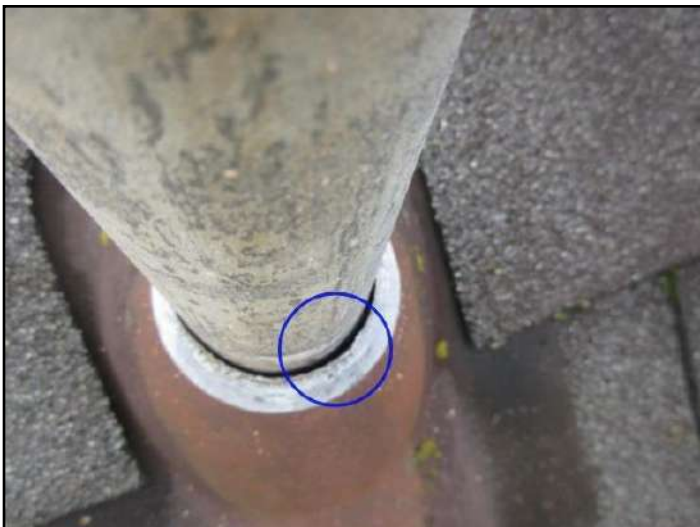
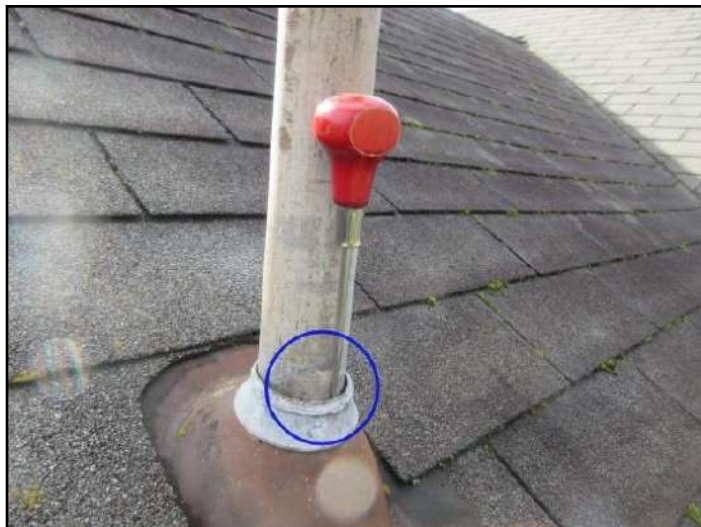
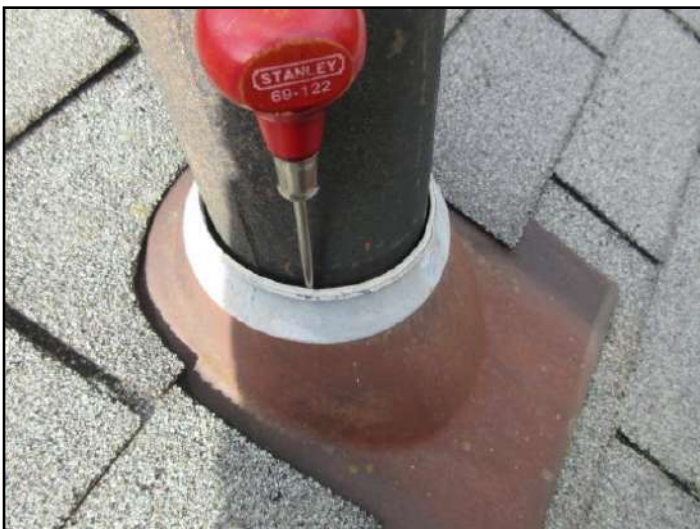
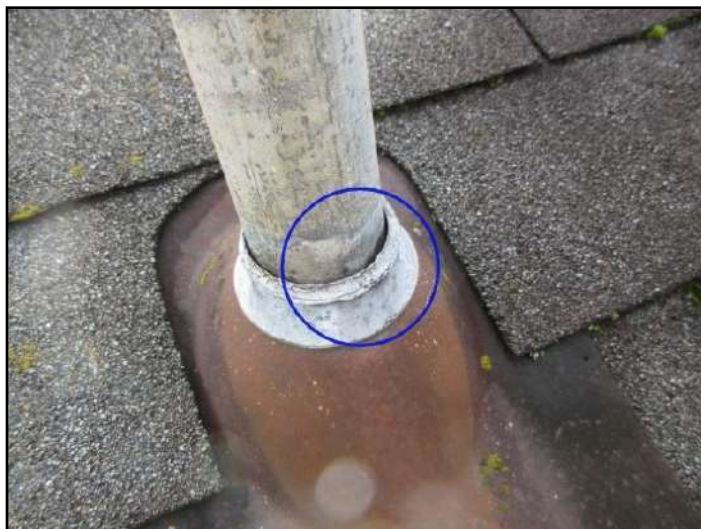
4. Condition: • [Leak](#)

Implication(s): Chance of water damage to contents, finishes and/or structure

Location: East Roof

Task: Correct

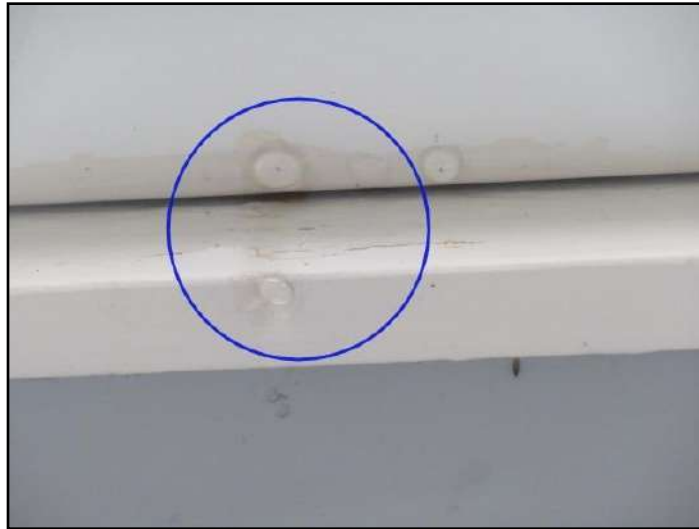
5. Condition: • [Leak](#)

Implication(s): Chance of water damage to contents, finishes and/or structure

25. Leak

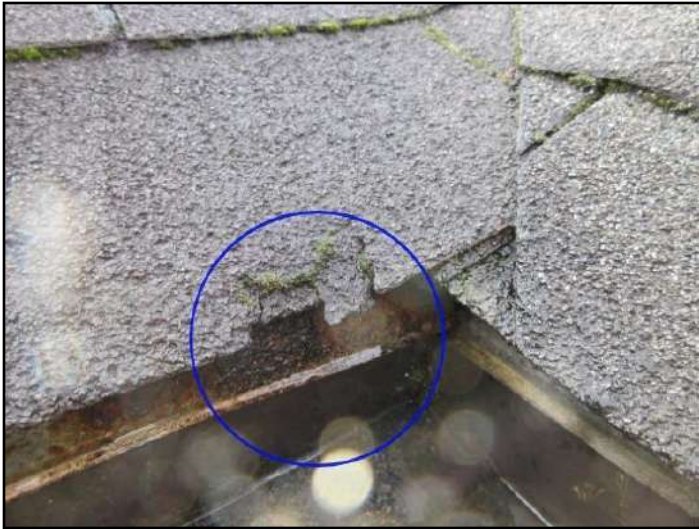
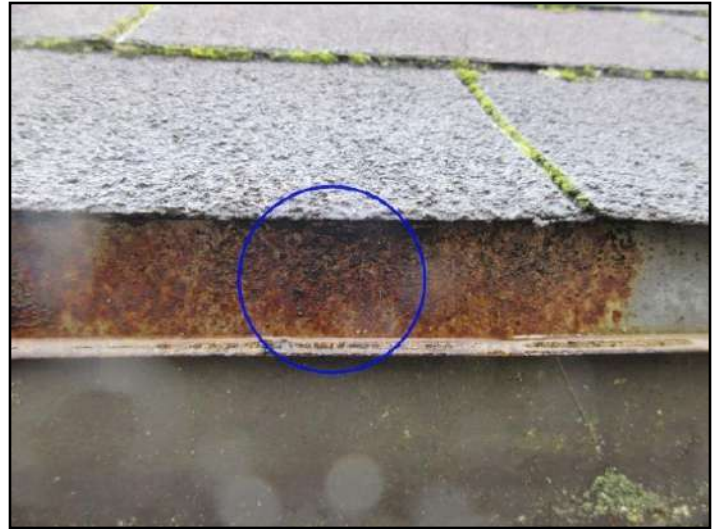
## 6. Condition: • [Rust](#)

**Implication(s):** Chance of water damage to contents, finishes and/or structure

**Location:** East Roof

**Task:** Further evaluation Monitor

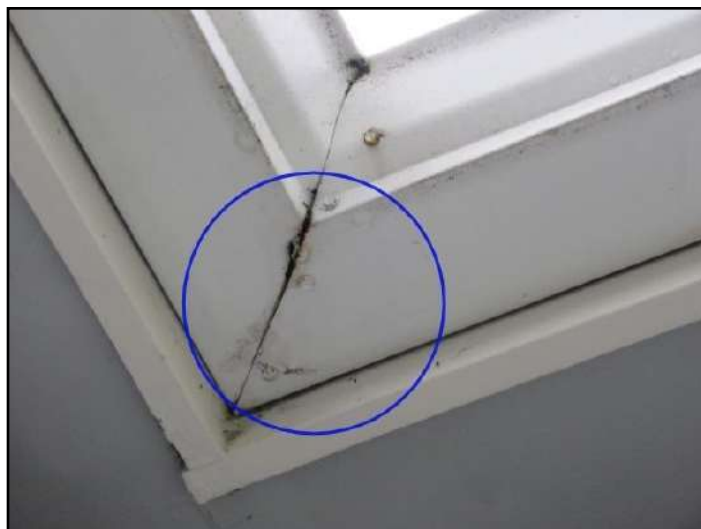
8. Condition: • [Leak](#)

30. Leak

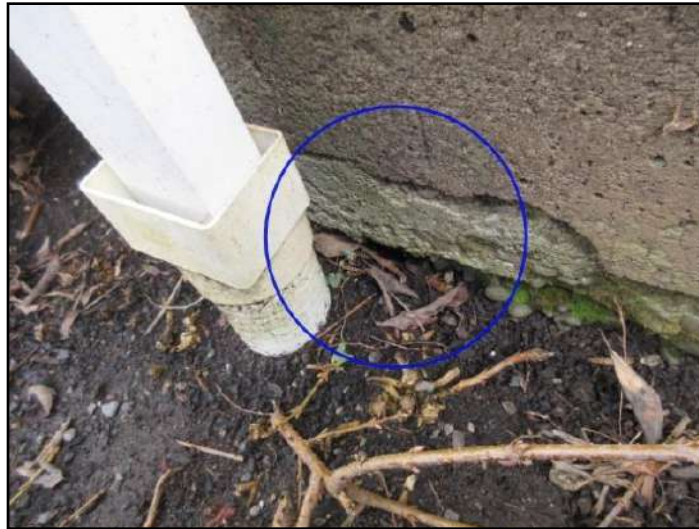
**9. Condition:** • Spalling foundation

**Implication(s):** Possible damage to finishes and/or structure

31. Confirm downspout operation

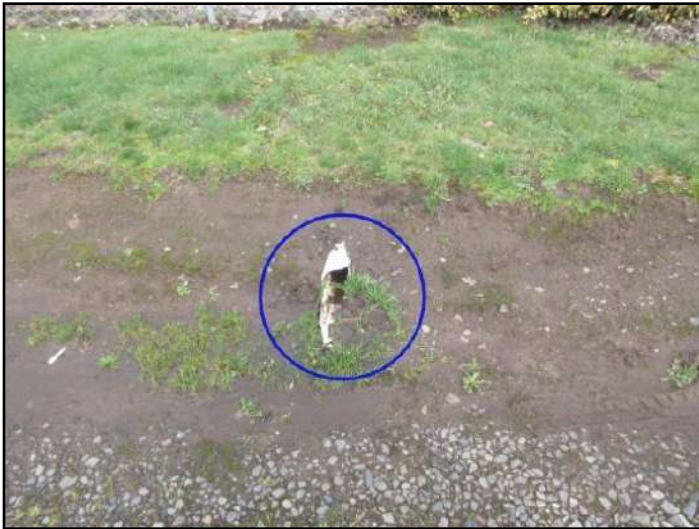
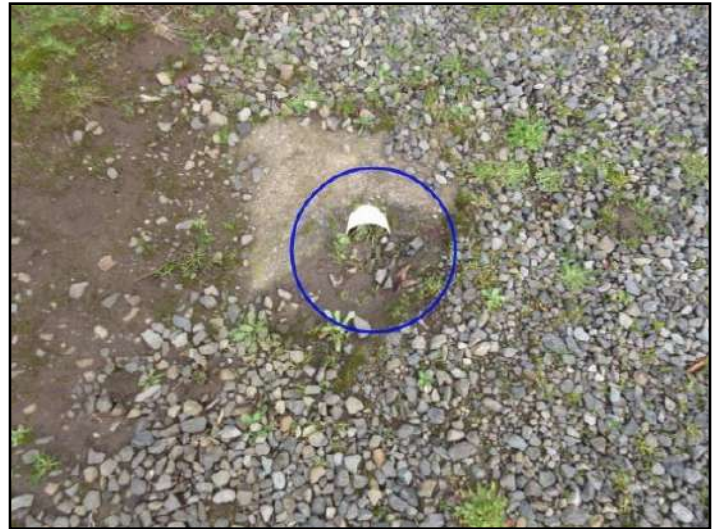
## 10. Condition: • [Clogged](#)

**Implication(s):** Chance of water damage to contents, finishes and/or structure

32. *Damaged*

33. *Clogged*

Recommend confirming gutter and downspout operation

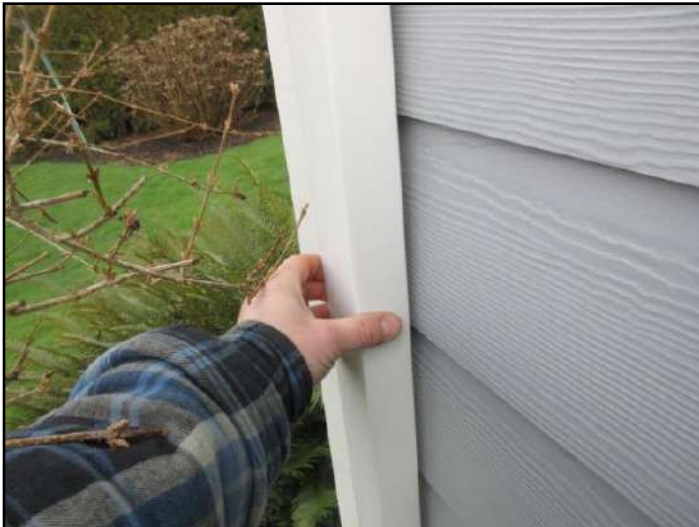
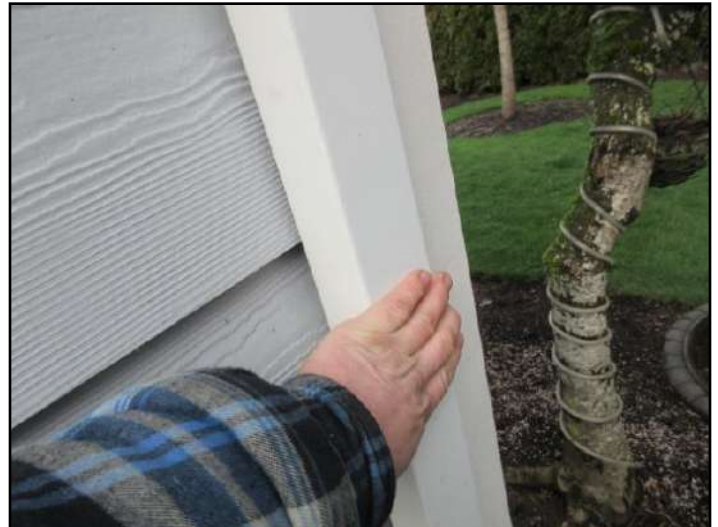
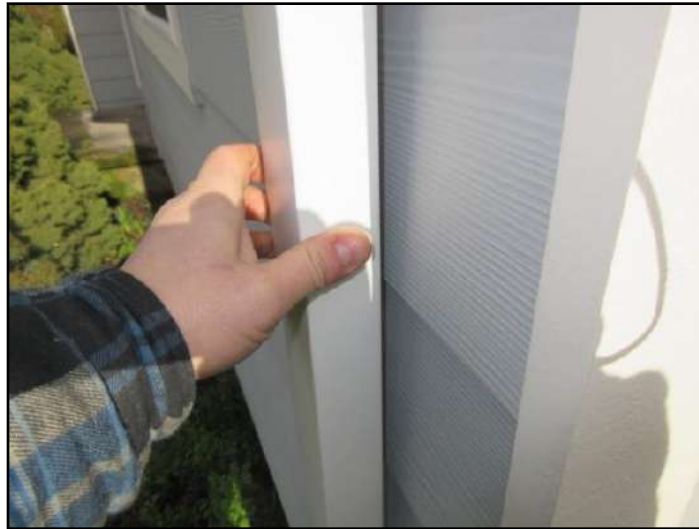
11. **Condition:** • Loose

**Location:** Throughout Exterior

**Task:** Improve

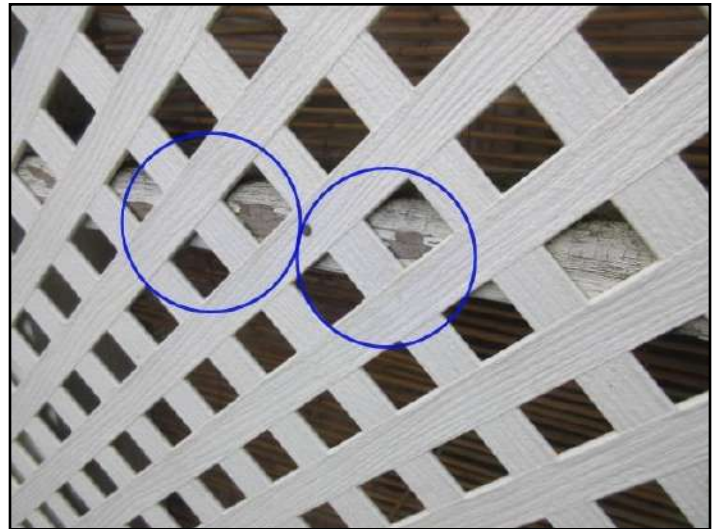
12. Condition: • [Paint](#)

38. Paint

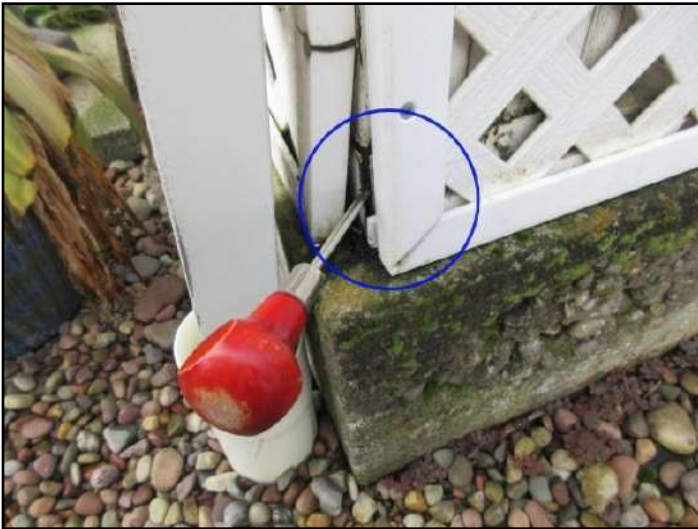
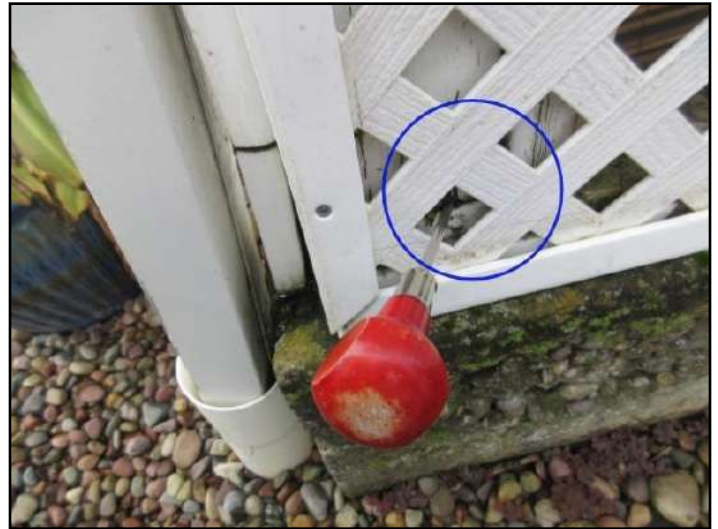
13. Condition: • Rot

Implication(s): Chance of water damage to contents, finishes and/or structure | Material deterioration

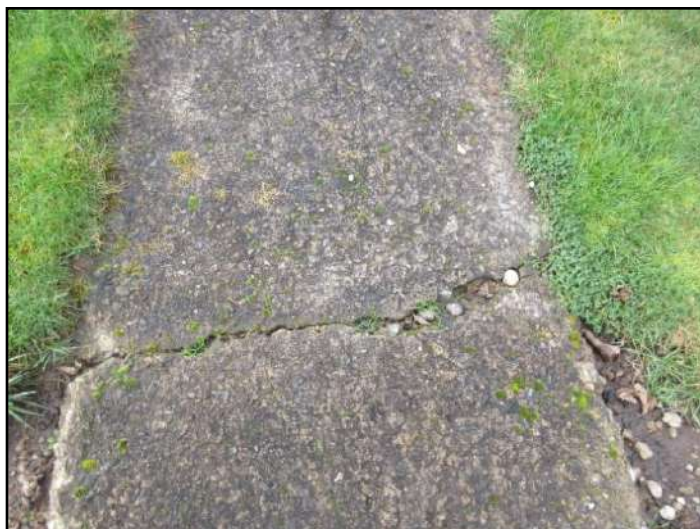
15. Condition: • [Cracked or damaged surfaces](#)

Implication(s): Trip or fall hazard

Location: West Exterior

Task: Monitor

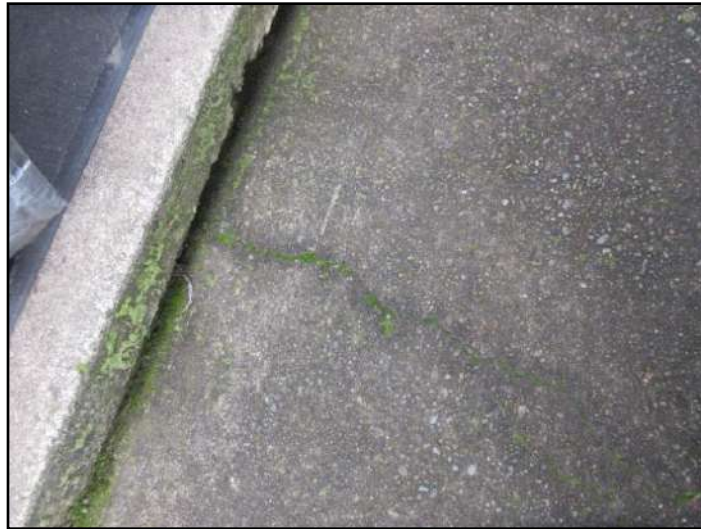
16. Condition: • [Cracked or damaged surfaces](#)

44. Cracked or damaged surfaces

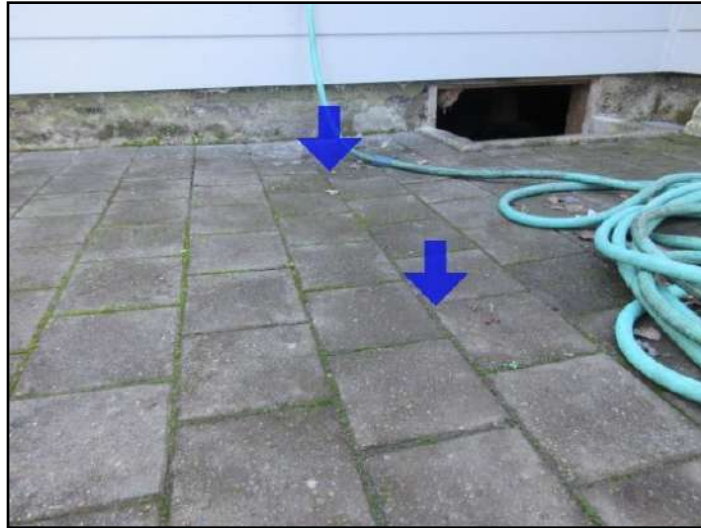
**17. Condition:** • Improper slope or drainage

**Implication(s):** Chance of water damage to contents, finishes and/or structure

**Location:** East Exterior

**Task:** Improve

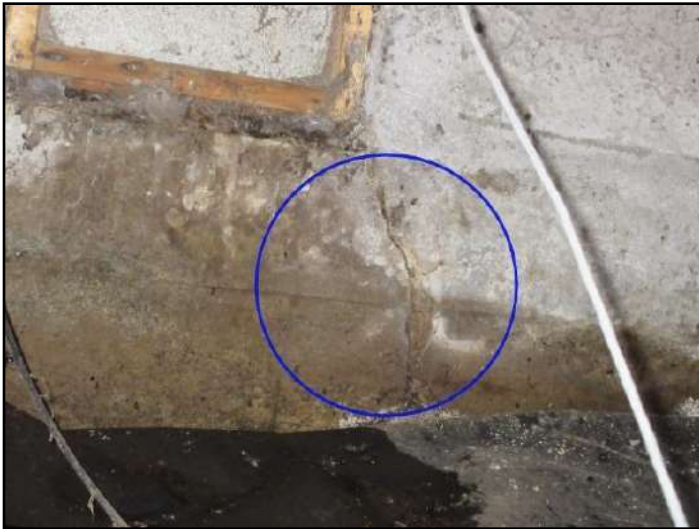
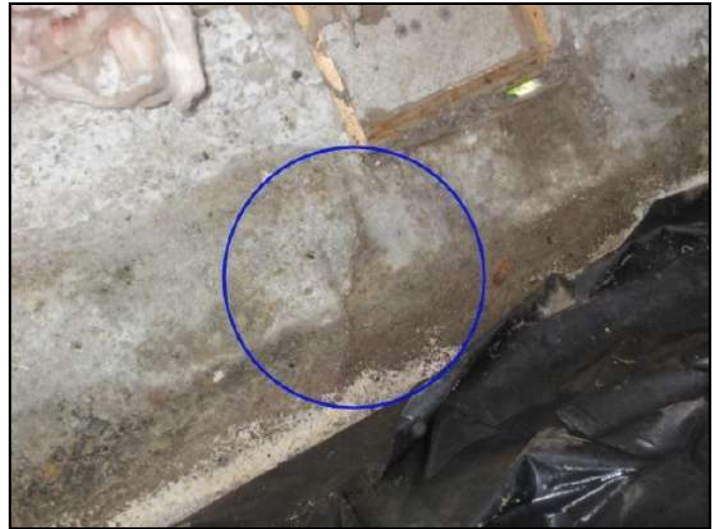
**18. Condition:** • Typical minor cracks

54. Typical minor cracks

55. Typical minor cracks

**Task:** Further evaluation Monitor

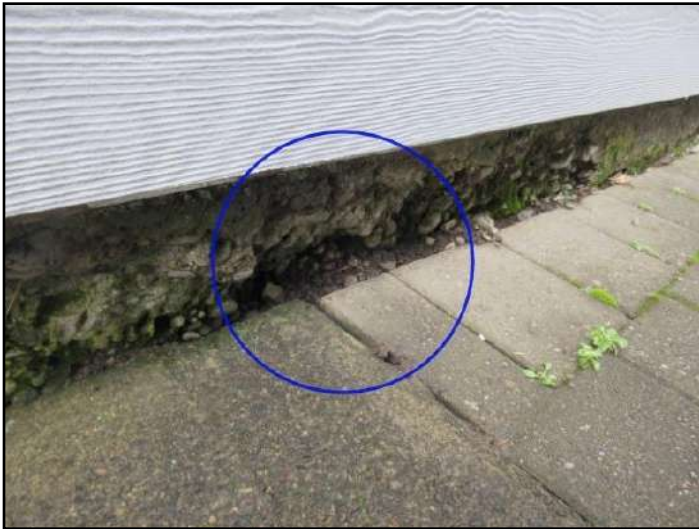
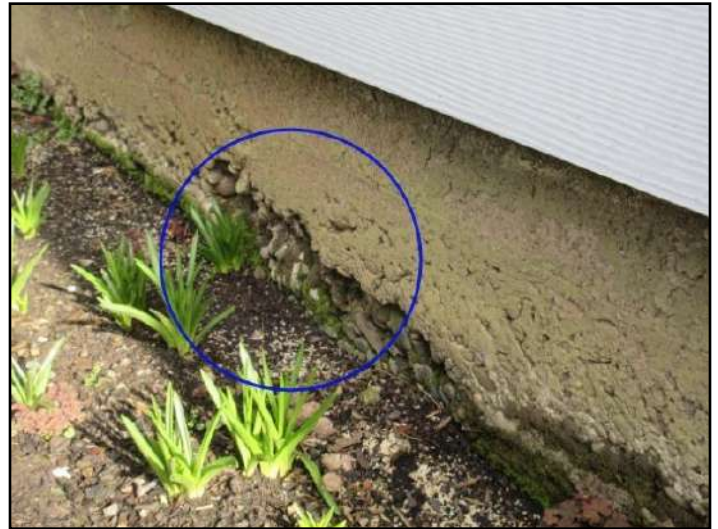
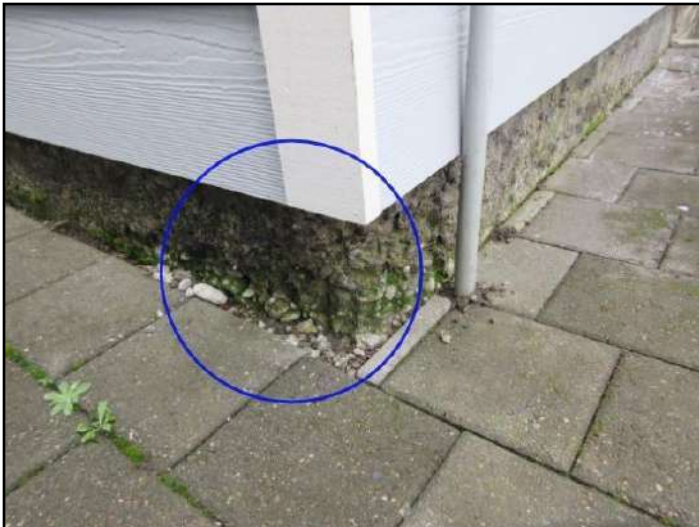
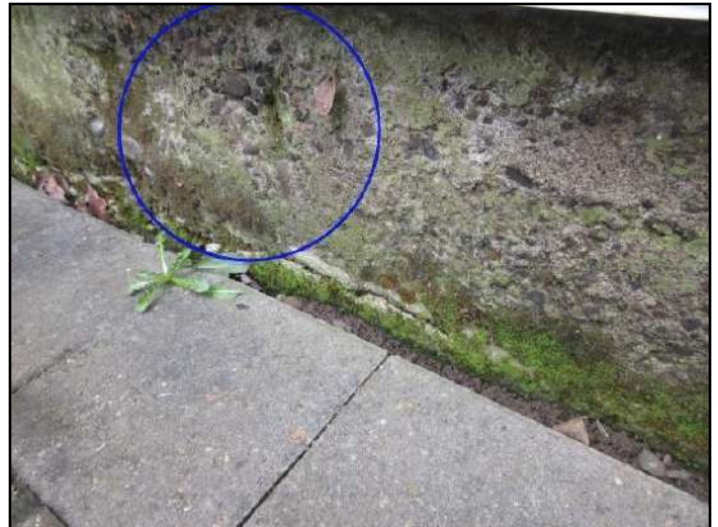
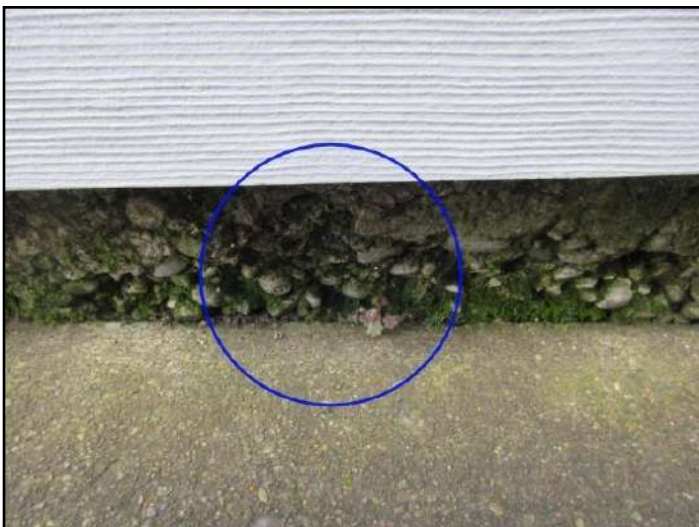
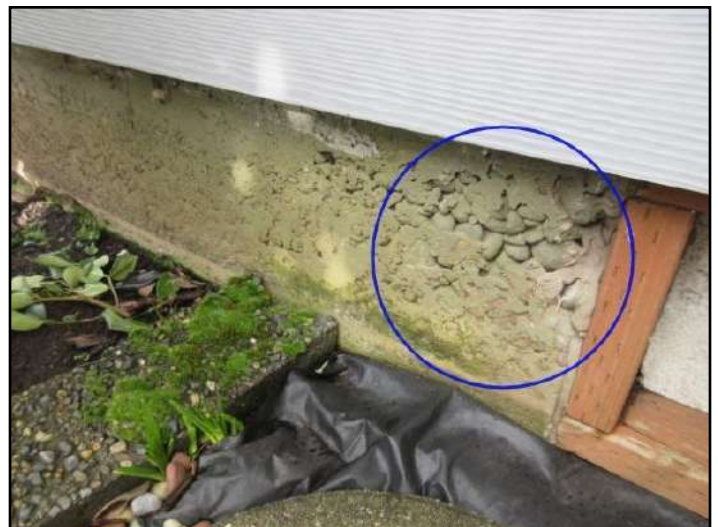
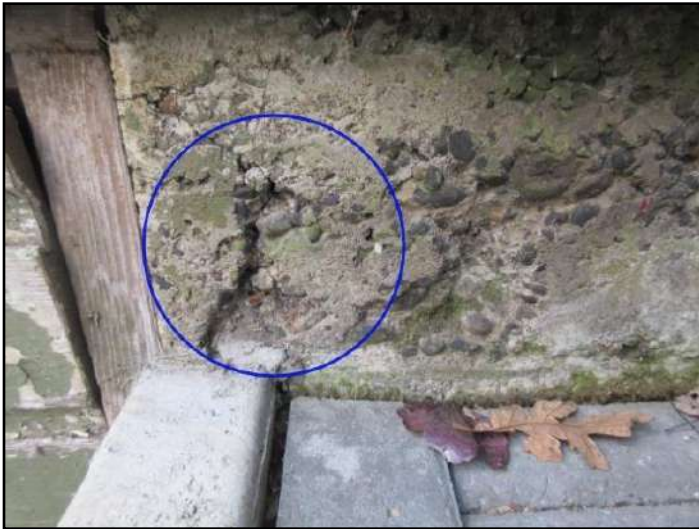
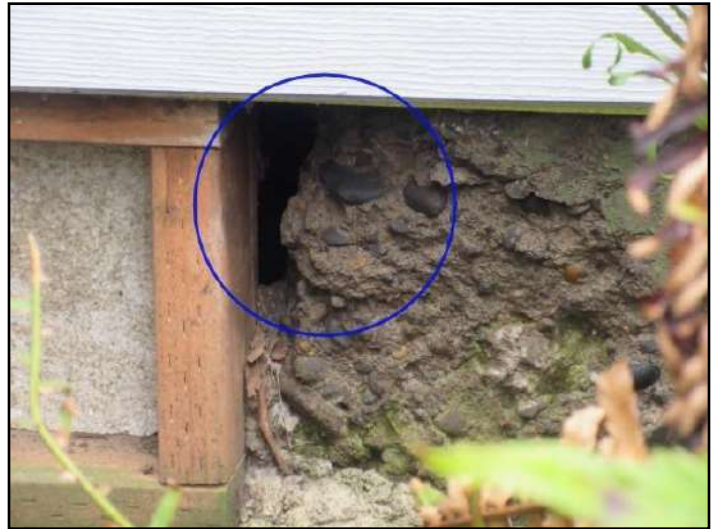
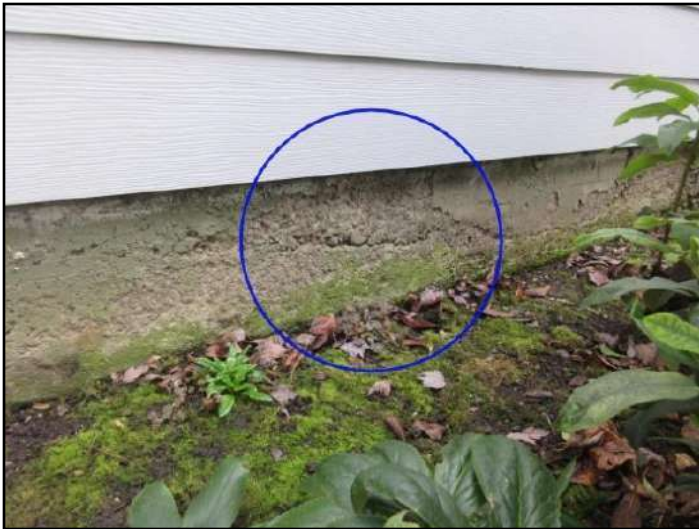
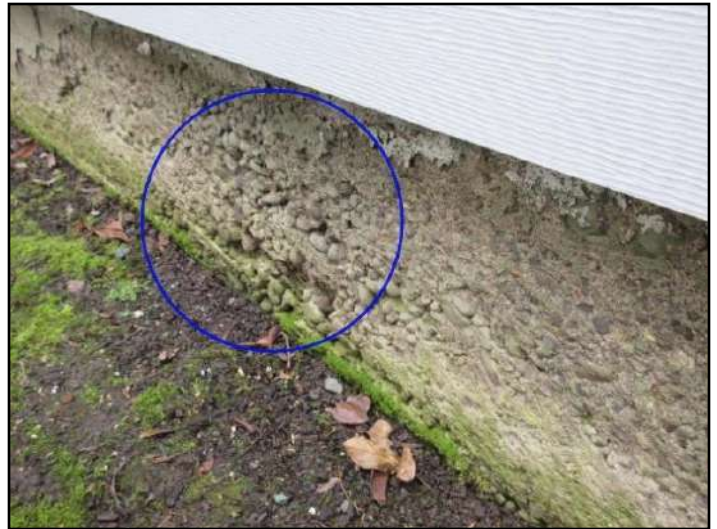
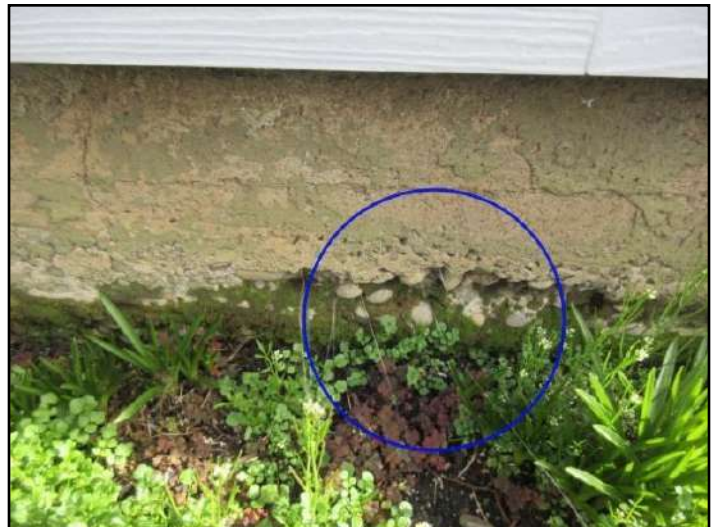
19. Condition: • [Spalling, crumbling or broken material](#)

Location: Throughout Exterior

Task: Further evaluation Monitor

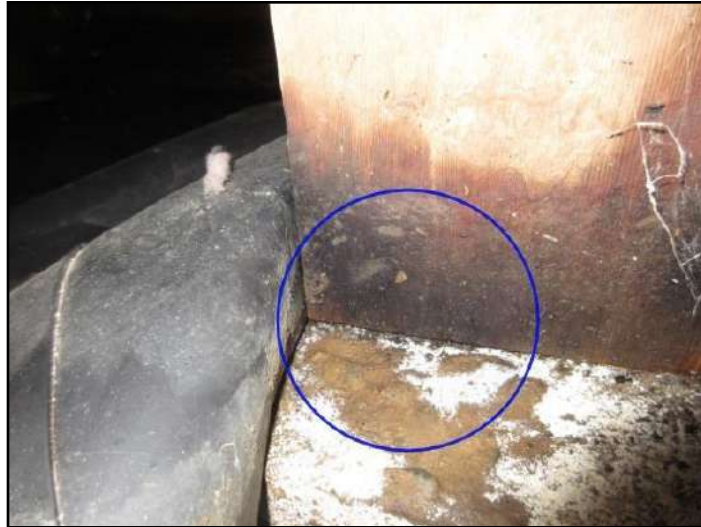
**20. Condition:** • Moisture break missing causing wooden post to absorb moisture from the concrete

**Implication(s):** Rot

**Location:** Crawl Space

**Task:** Correct

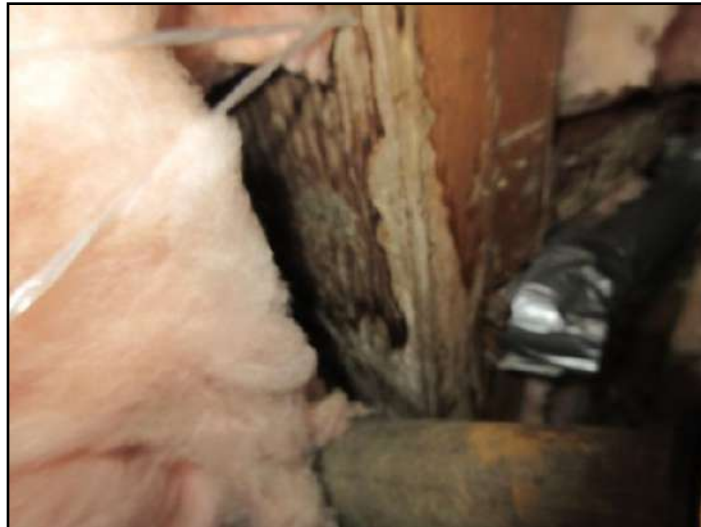
**21. Condition:** • Water stains

**Location:** Crawl Space

**Task:** Monitor

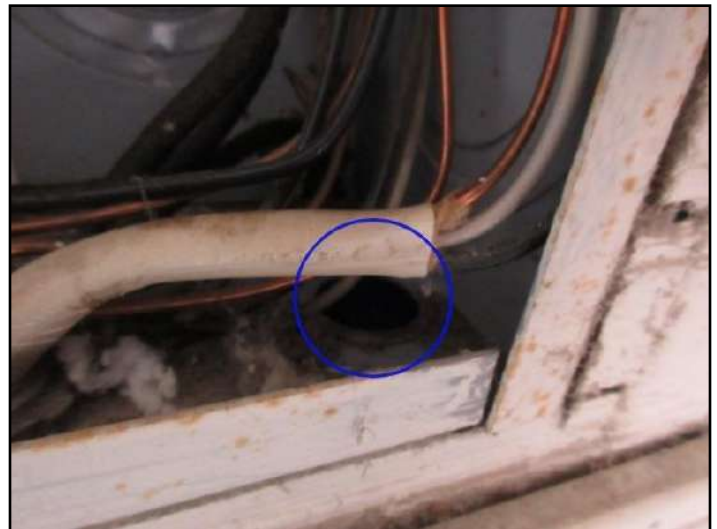
22. Condition: • [Openings in panel](#)

Implication(s): Electric shock | Fire hazard

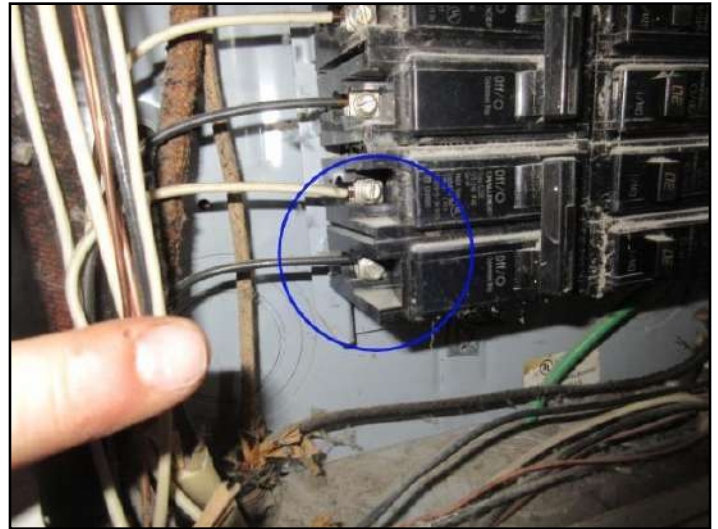
24. Condition: • [Fuses or breakers too big](#)

Implication(s): Equipment overheating | Fire hazard

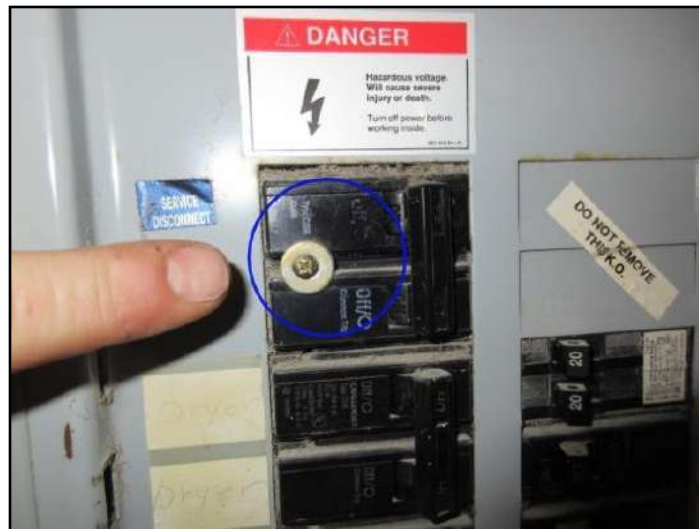
25. Condition: • [Loose breakers or fuses](#)

Implication(s): Electric shock | Fire hazard

Location: Laundry Area

Task: Further evaluation

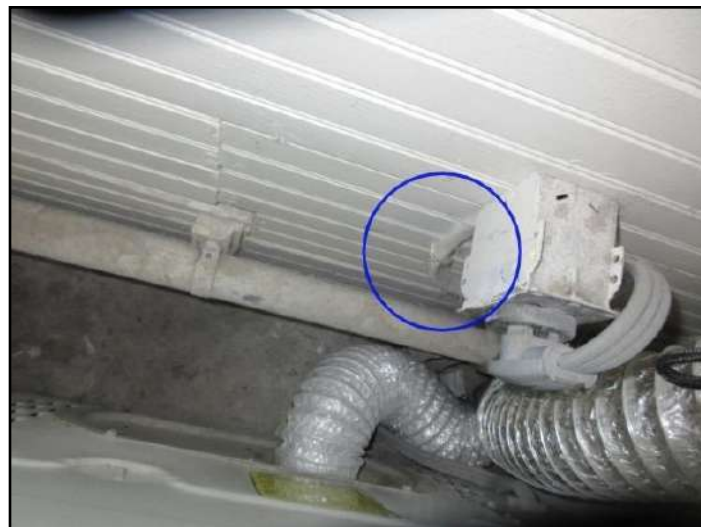
26. Condition: • [Flexible conduit needed](#)

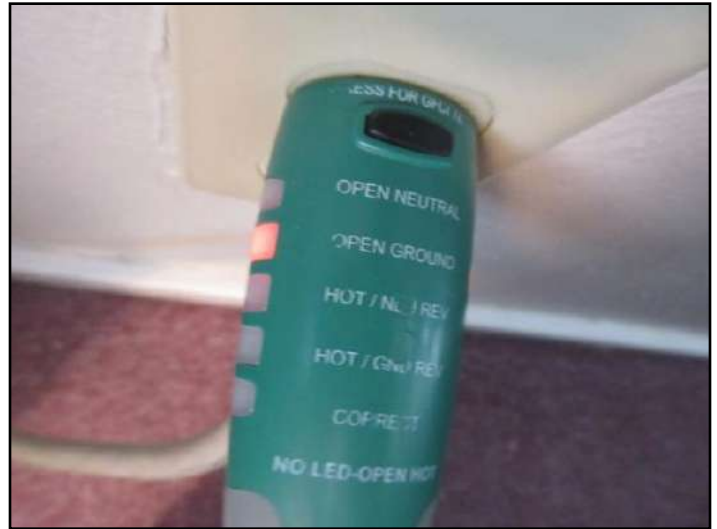
**DISTRIBUTION SYSTEM \ Outlets (receptacles)****27. Condition:** • [Ungrounded](#)**Implication(s):** Electric shock**Location:** Throughout**Task:** Improve

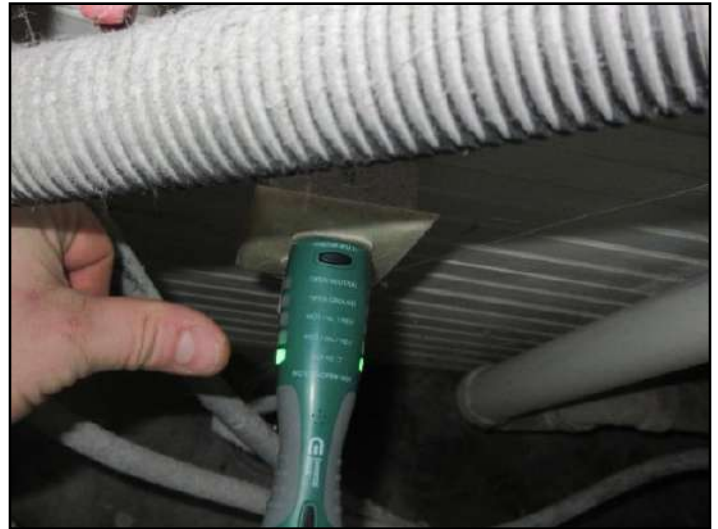
28. Condition: • [No GFCI/GFI \(Ground Fault Circuit Interrupter\)](#)

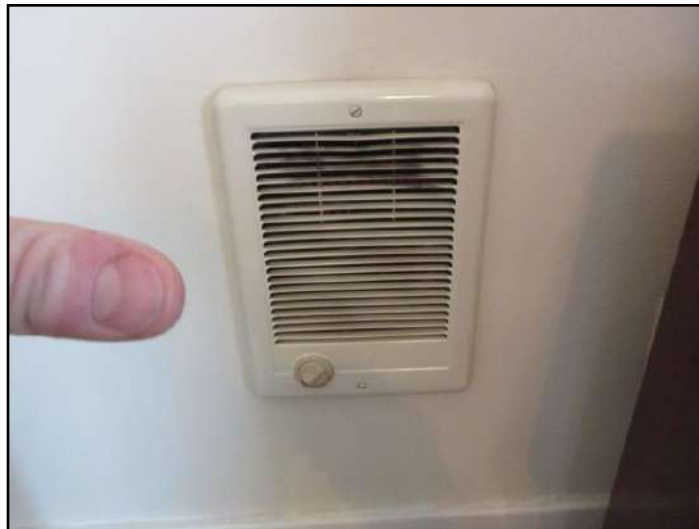
**30. Condition:** • [Fan noisy, inoperative, loose or dirty](#)

**Implication(s):** Reduced system life expectancy | Fire hazard | No heat for building

**Location:** Northeast Bedroom

**Task:** Repair or replace

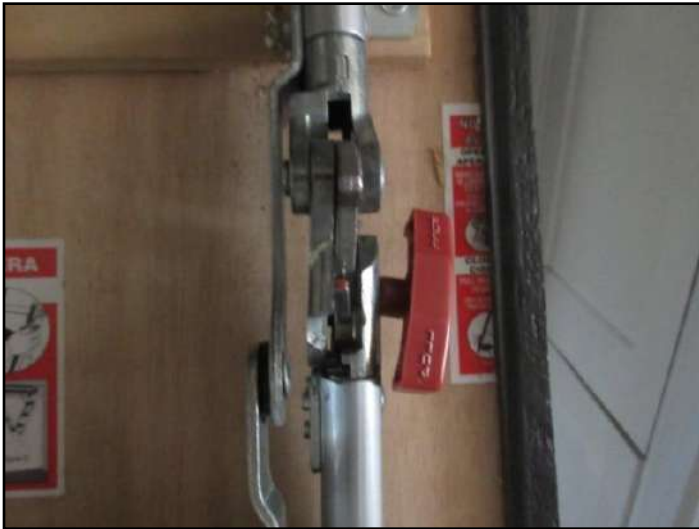
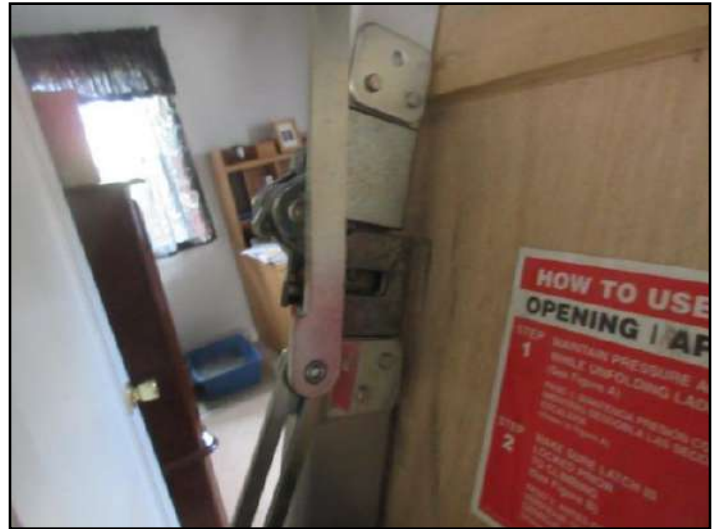
31. Condition: • [Unsafe to climb](#)

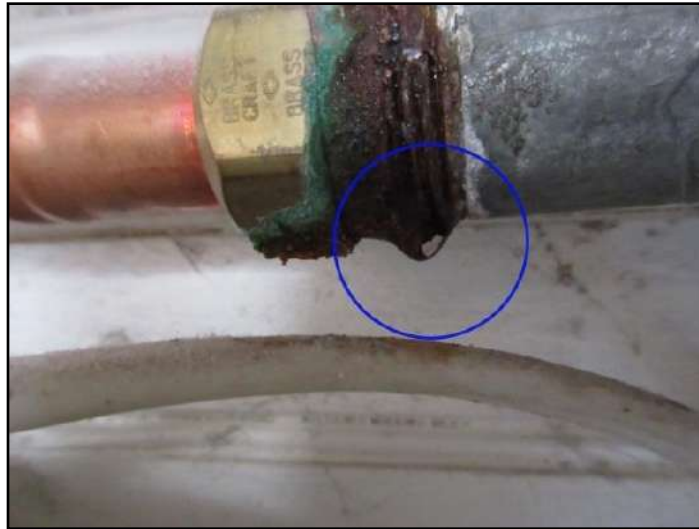
33. Condition: • [Leak](#)

Implication(s): Chance of water damage to contents, finishes and/or structure | System inoperative

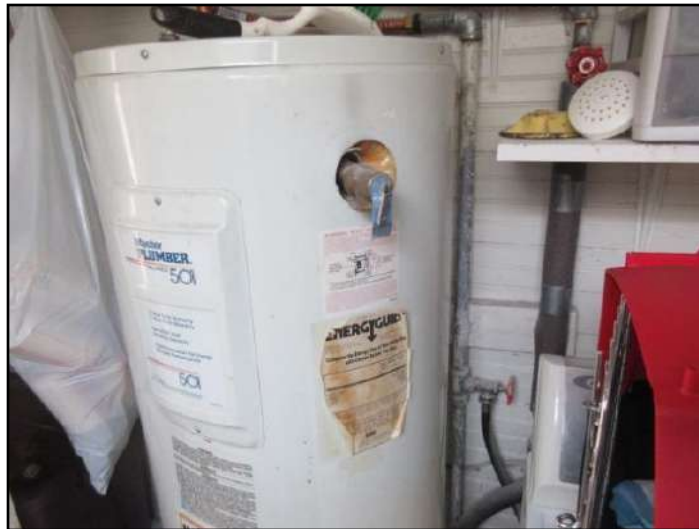
34. Condition: • Missing seismic straps

Location: Laundry Area

Task: Correct

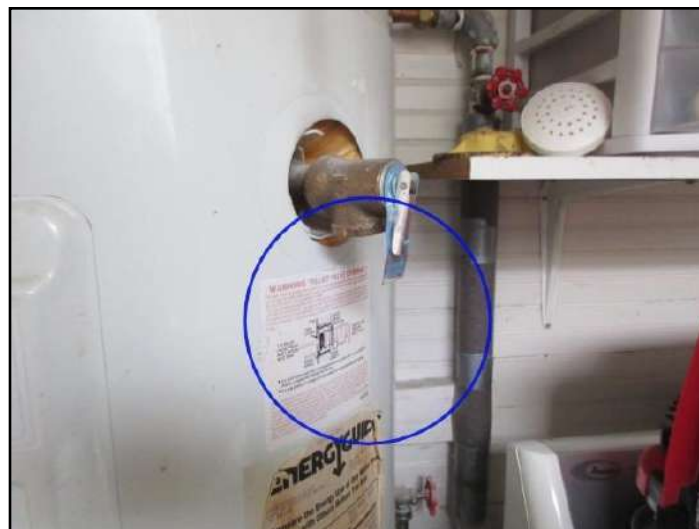
35. Condition: • [Discharge tube missing](#)

Location: Laundry Area

Task: Correct

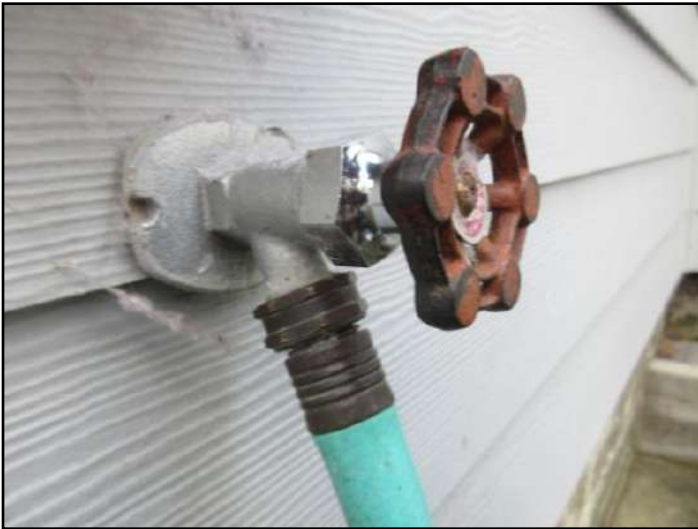
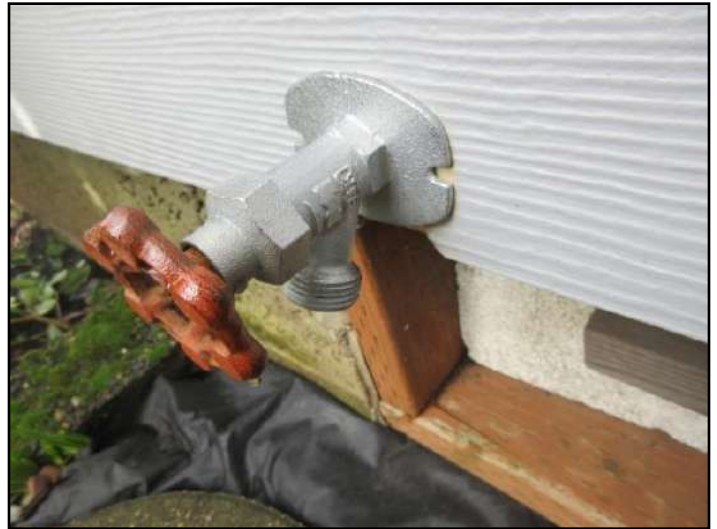
37. Condition: • [Backflow prevention missing](#)

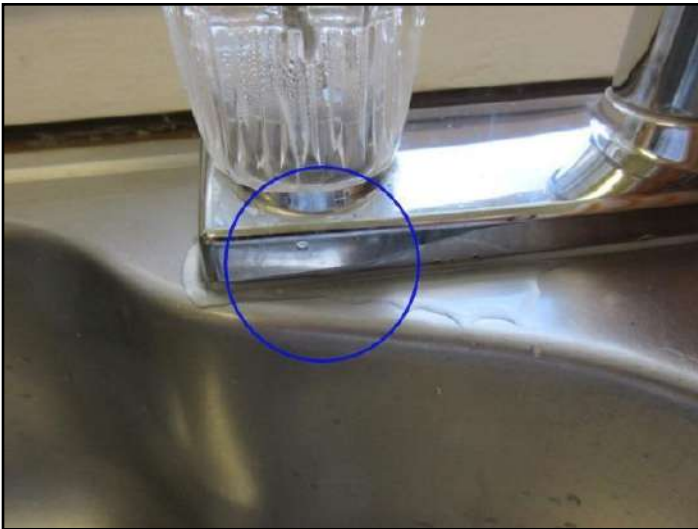
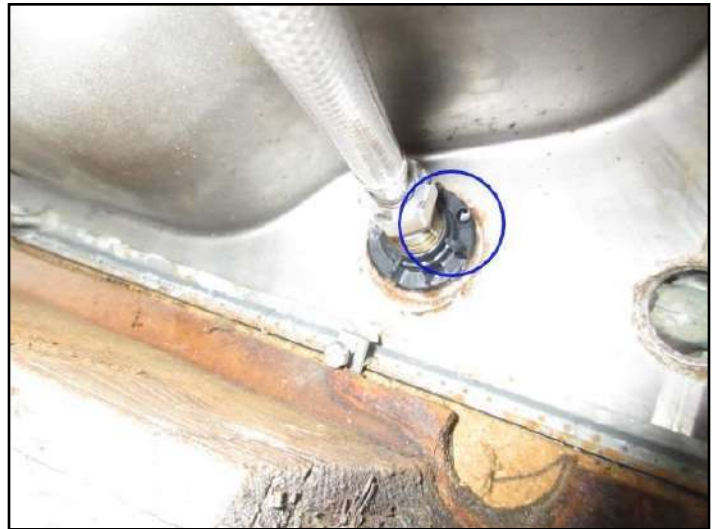
38. Condition: • [Drip, leak](#)

Implication(s): Chance of water damage to contents, finishes and/or structure

Location: Kitchen

Task: Correct

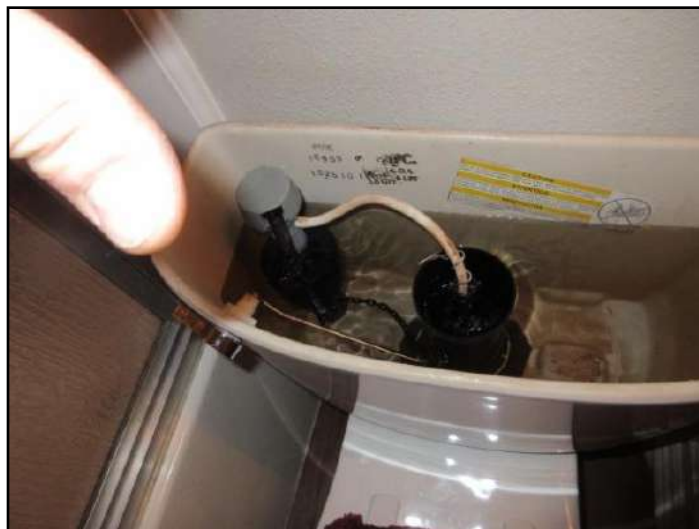
### 41. Condition: • [Flush mechanism inoperative](#)

**Implication(s):** Equipment failure | Sewage entering the building

126. Flush mechanism was inoperative

**Task:** Monitor

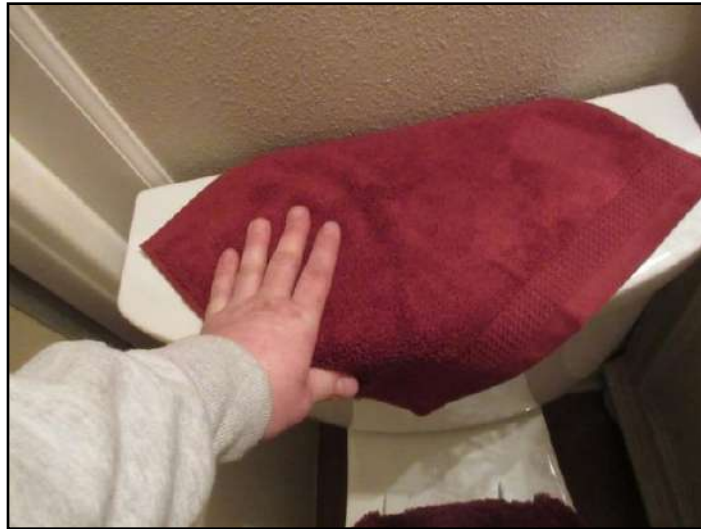
**42. Condition:** • [Loose](#)

**Implication(s):** Chance of water damage to contents, finishes and/or structure | Sewage entering the building | Possible hidden damage

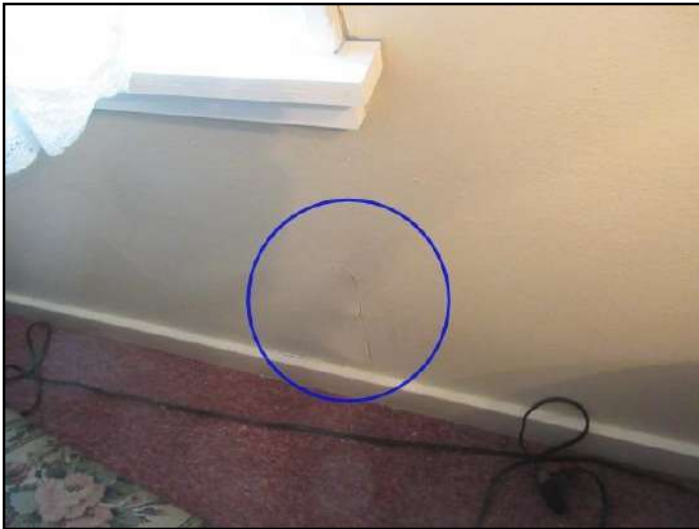
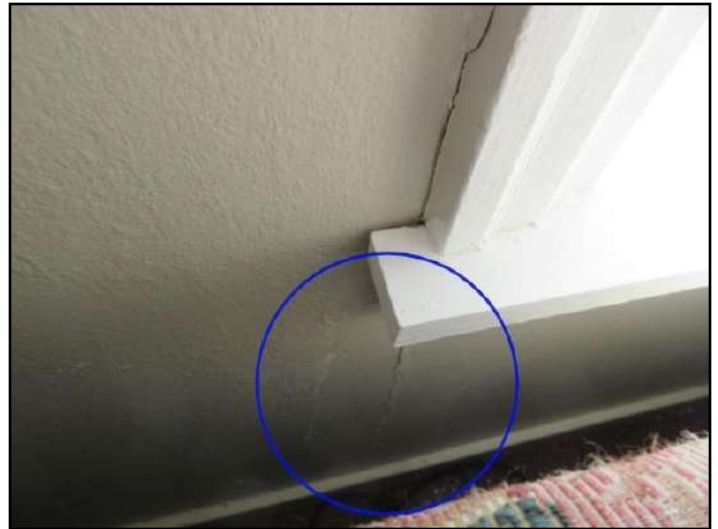
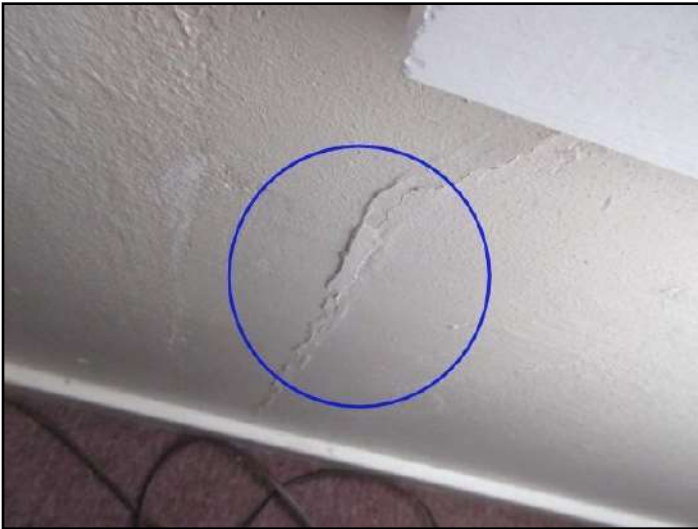
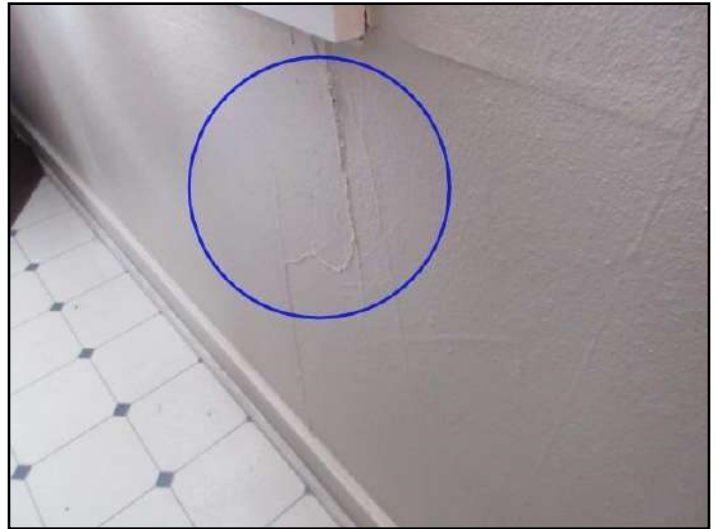
**43. Condition:** • Cracks

**Location:** Dining Room Living Room

**Task:** Monitor
