# YOUR INSPECTION REPORT

123 Main St  
Oregon, OR

Monday, February 3, 2020

RE: Report No. 1127  
123 Main St  
Oregon, OR

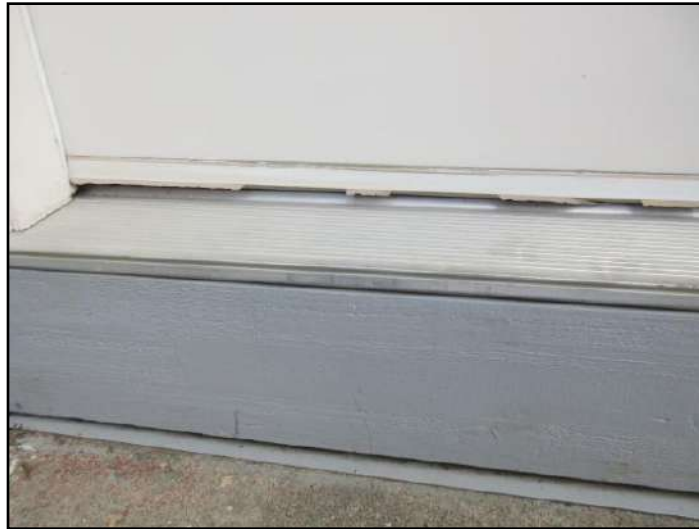
**46. Condition:** • [Weatherstripping missing or ineffective](#)

**Location:** West Exterior

**Task:** Improve

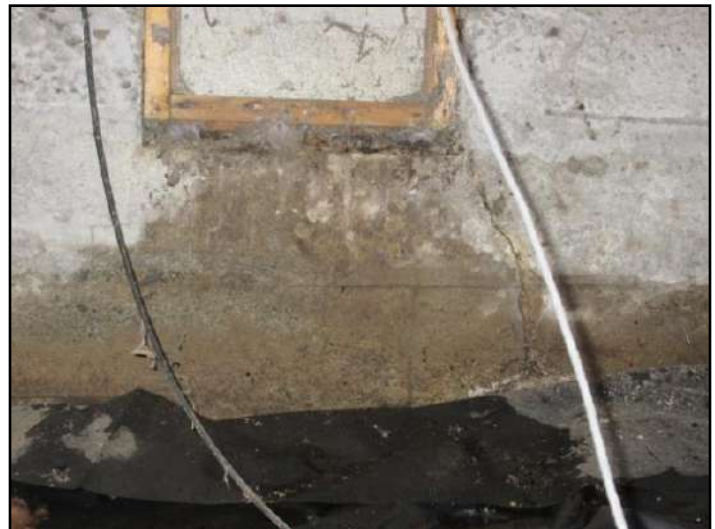
47. Condition: • [Water marks](#)

Implication(s): Chance of water damage to contents, finishes and/or structure
