# YOUR INSPECTION REPORT

123 Main St  
Oregon, OR

Monday, February 3, 2020

RE: Report No. 1127  
123 Main St  
Oregon, OR

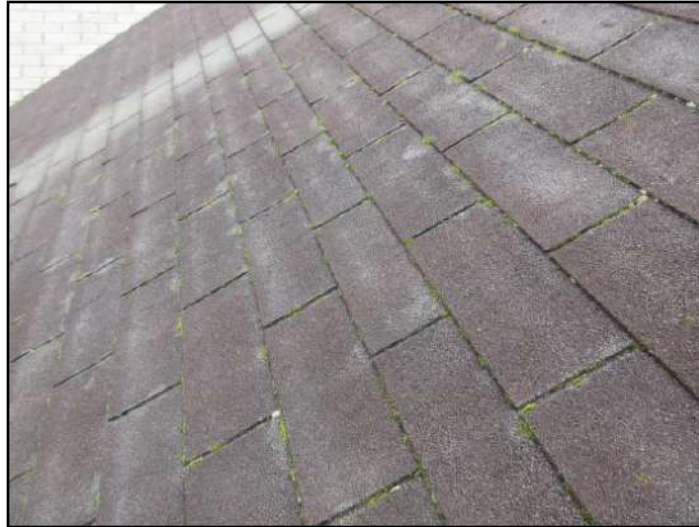
3. Wet roof surface hides flaws

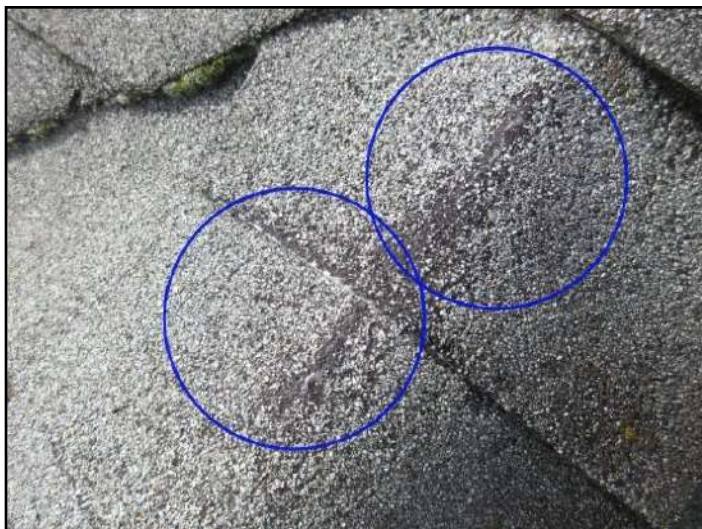
6. Granule loss

**Task:** Further evaluation Monitor

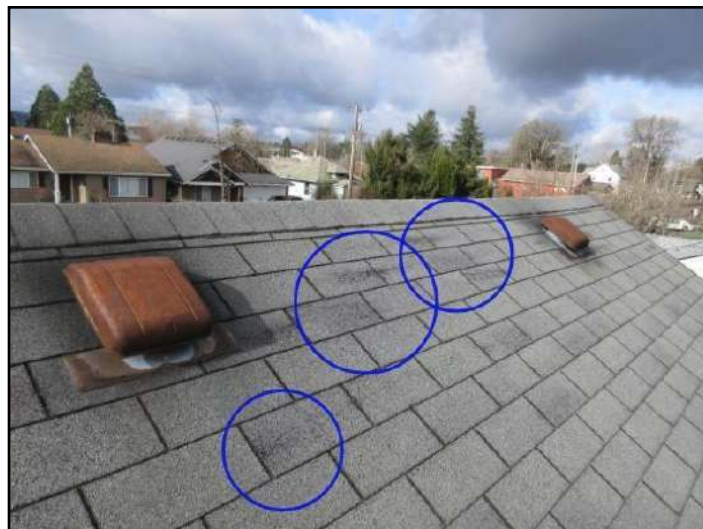
7. Granule loss

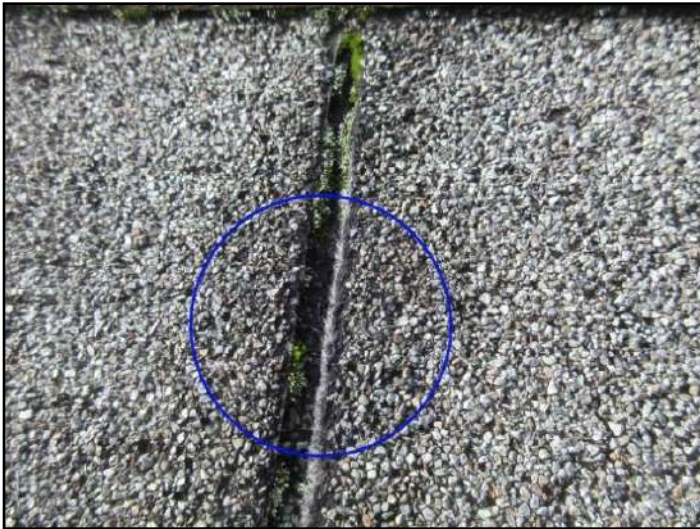
8. Granule loss

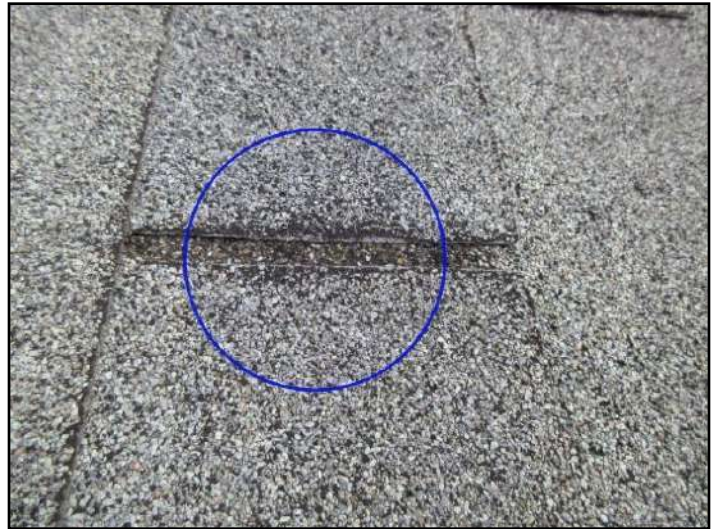
9. Granule loss

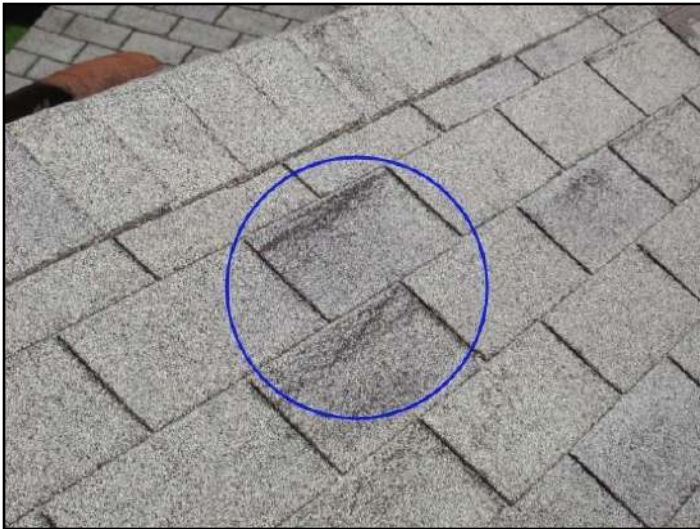
10. Granule loss

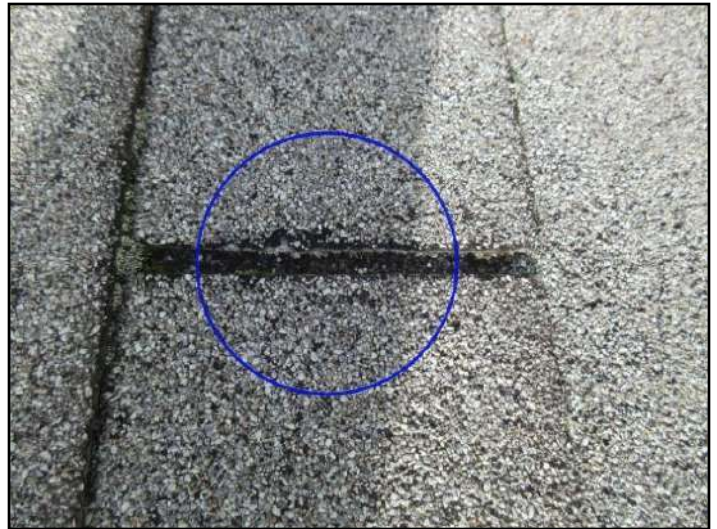
11. Granule loss

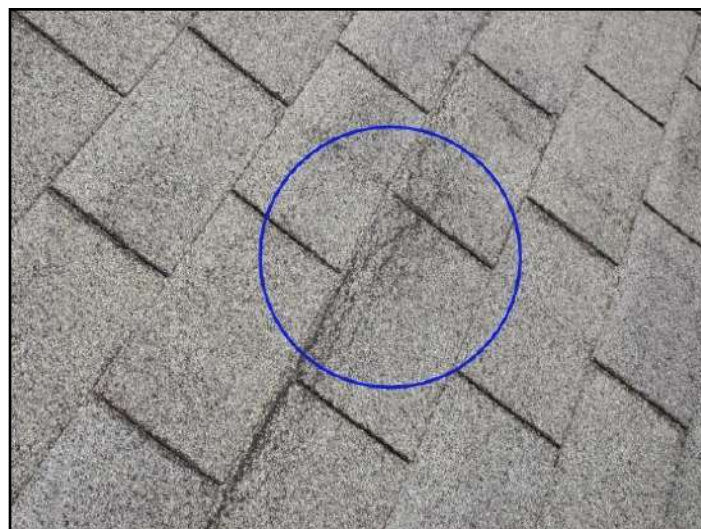
12. Granule loss

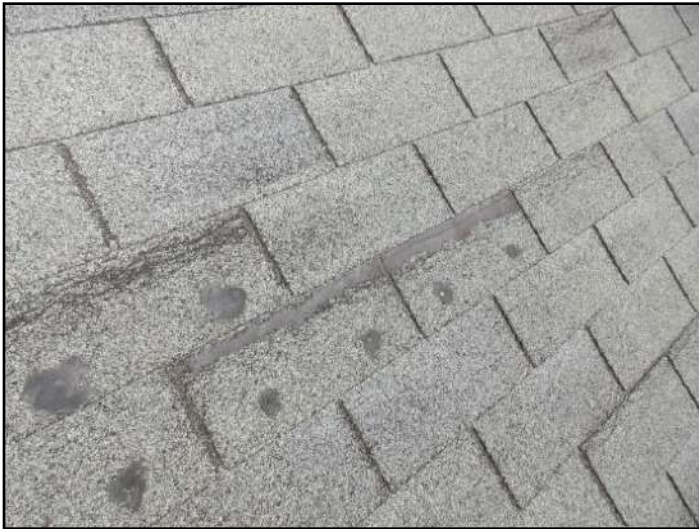
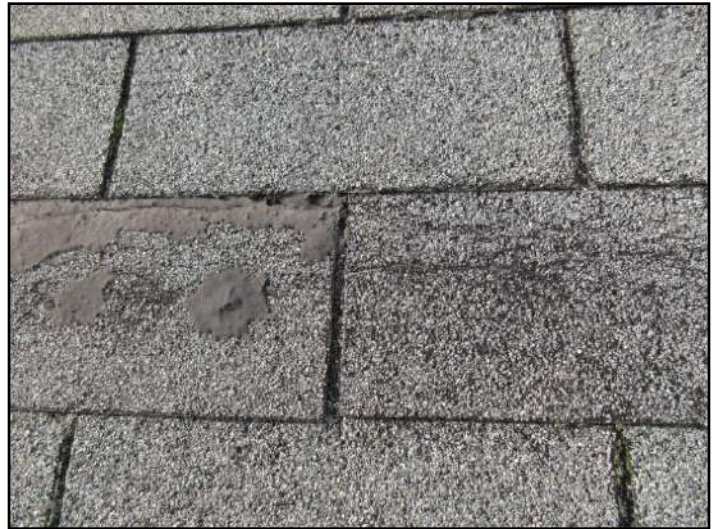
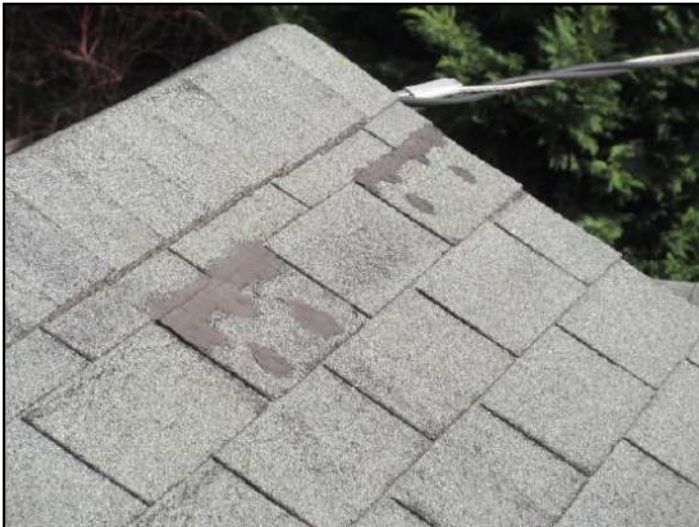
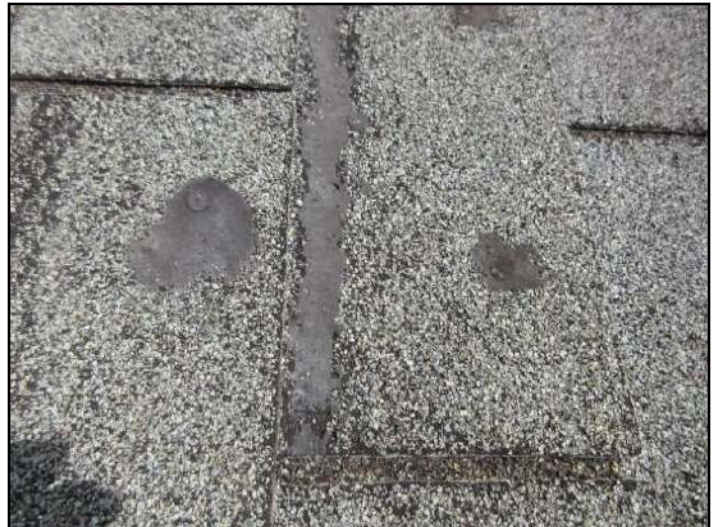
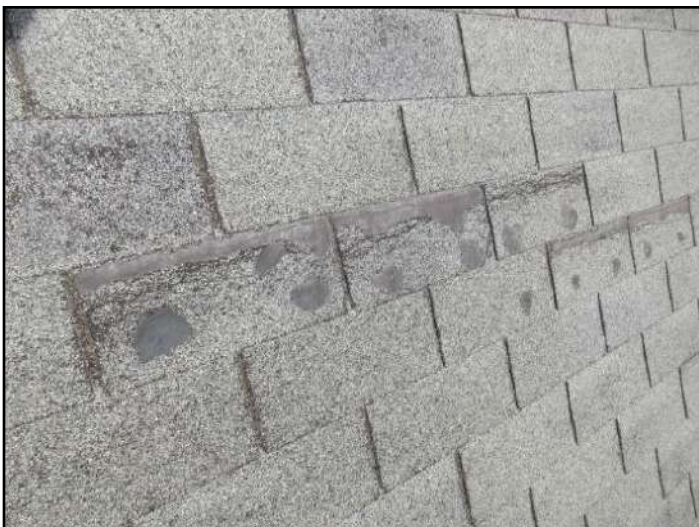
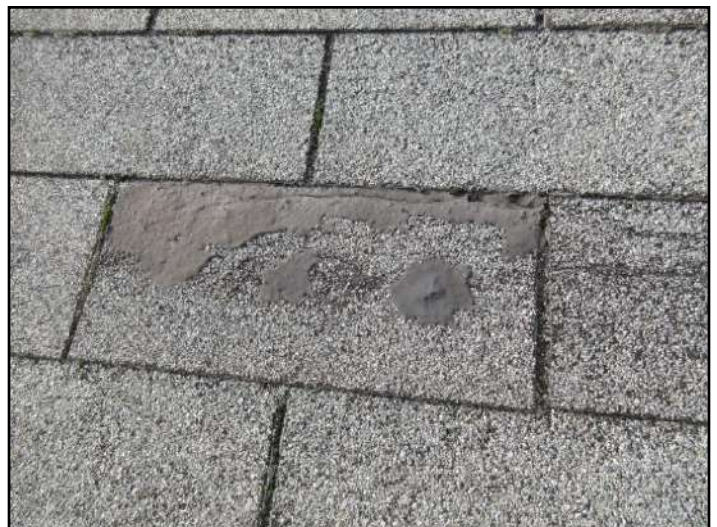
15. Patched

16. Patched

17. Patched

18. Patched

19. Patched

20. Patched

**Task:** Further evaluation Monitor

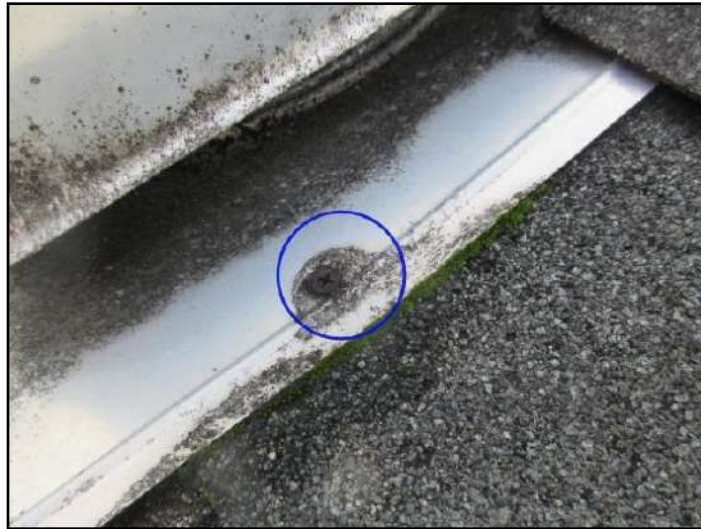
**28.** *Exposed fasteners not sealed*

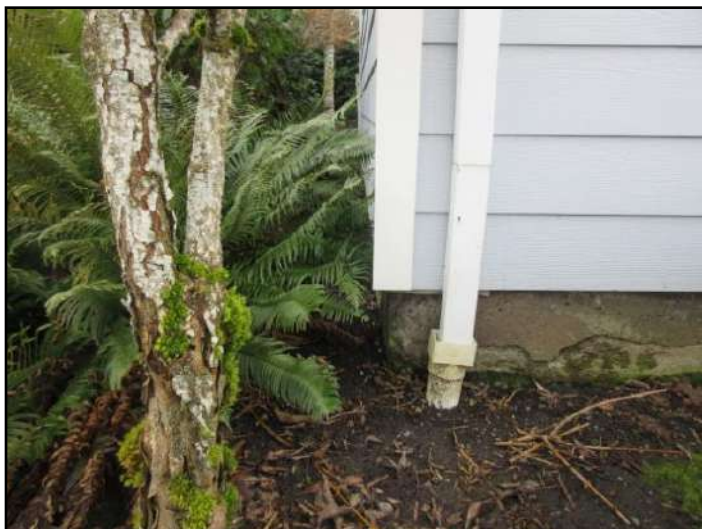
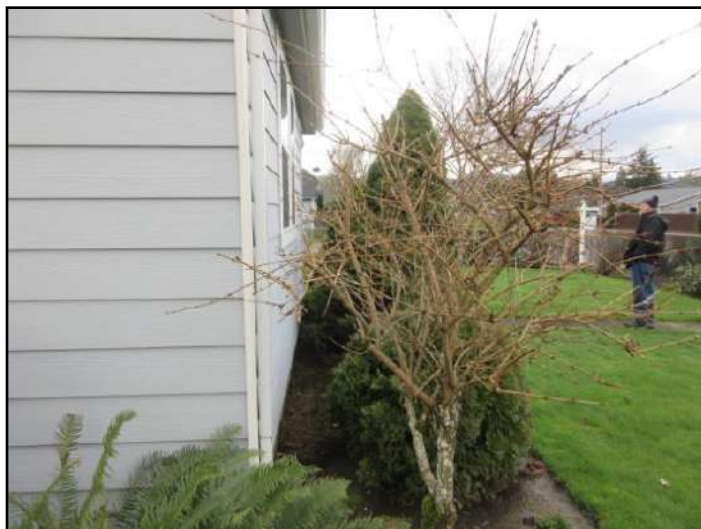
41. Trees or shrubs too close to building

42. Trees or shrubs too close to building

Task: Improve

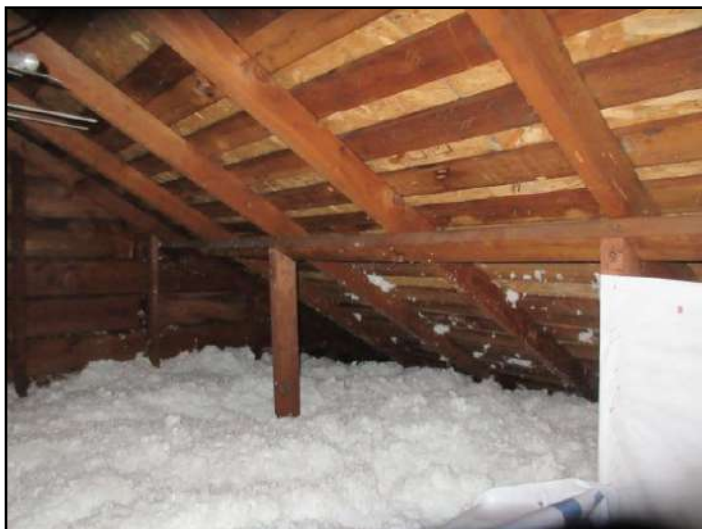
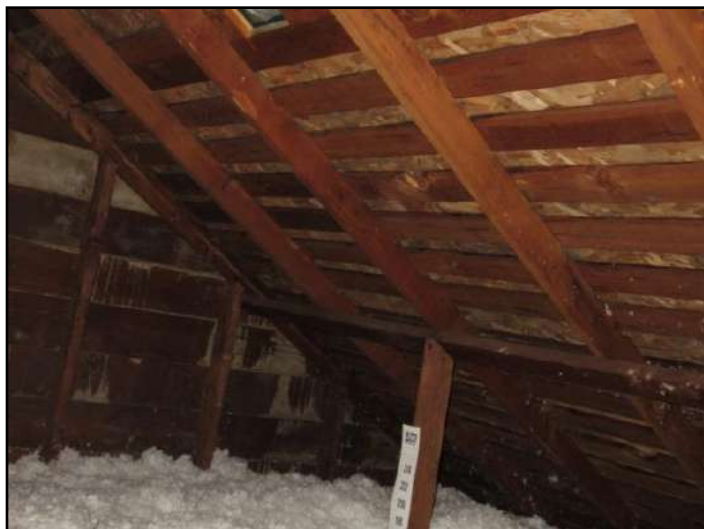
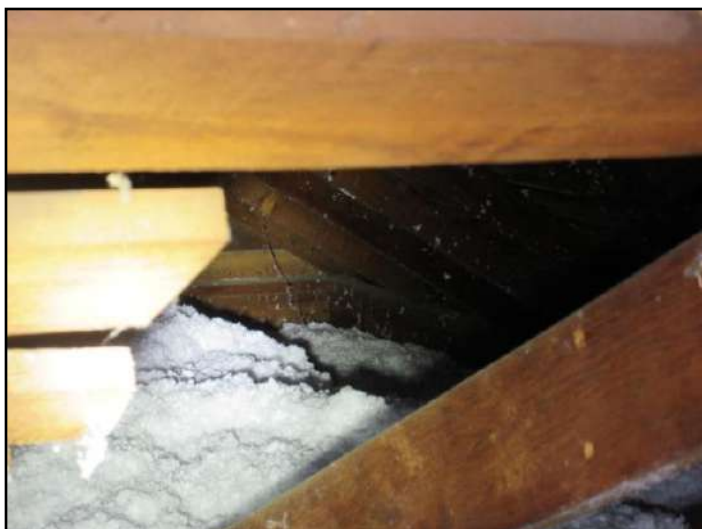
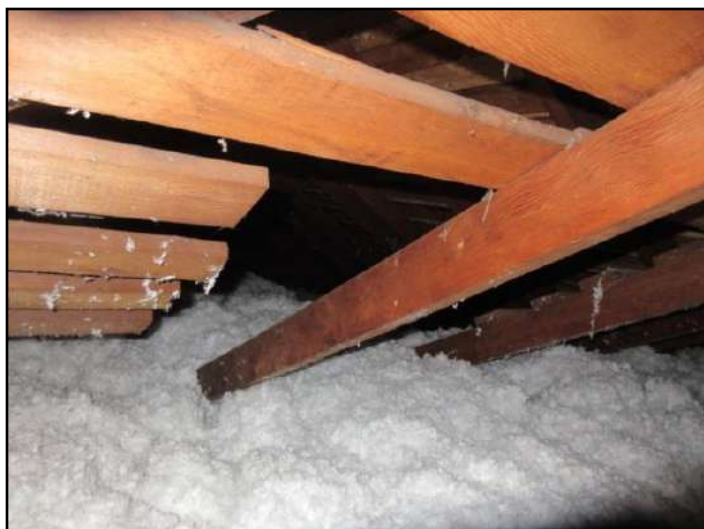
50. Entered but access was limited

51. Entered but access was limited

52. Entered but access was limited

53. Entered but access was limited

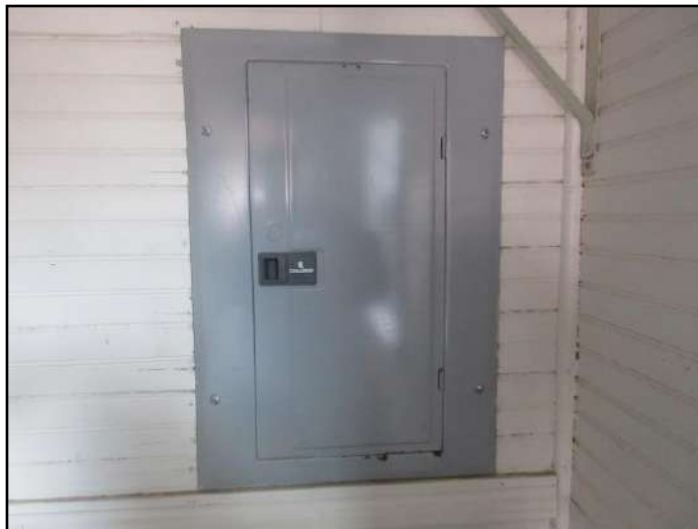
71. Breakers - utility room

Main disconnect/service box type and location:

- [Breakers - utility room](#)

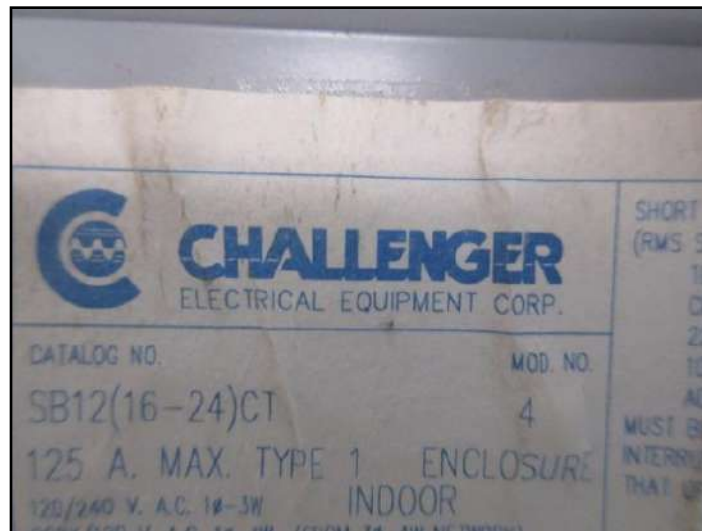
72. Challenger

Electrical panel manufacturers: • Challenger

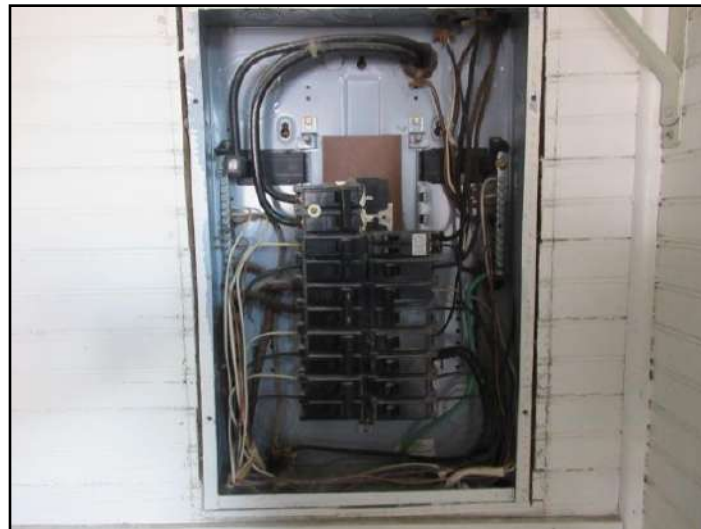
73. Copper - non-metallic sheathed

- [Copper - non-metallic sheathed](#)

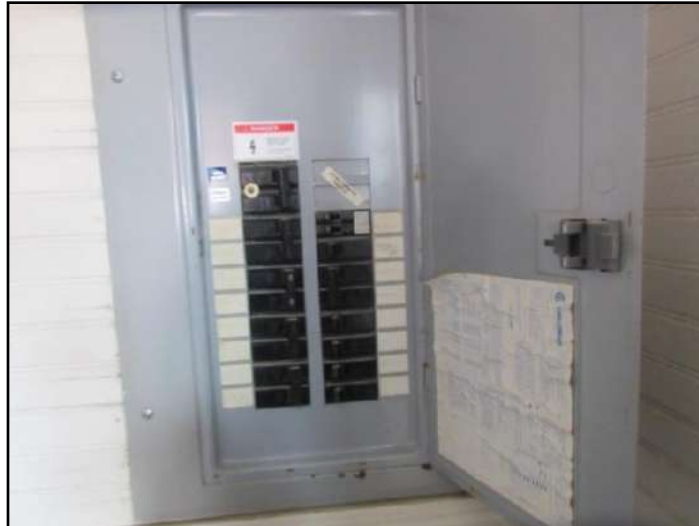
74. The accuracy of the circuit index (labels)...

- The accuracy of the circuit index (labels) was not verified.

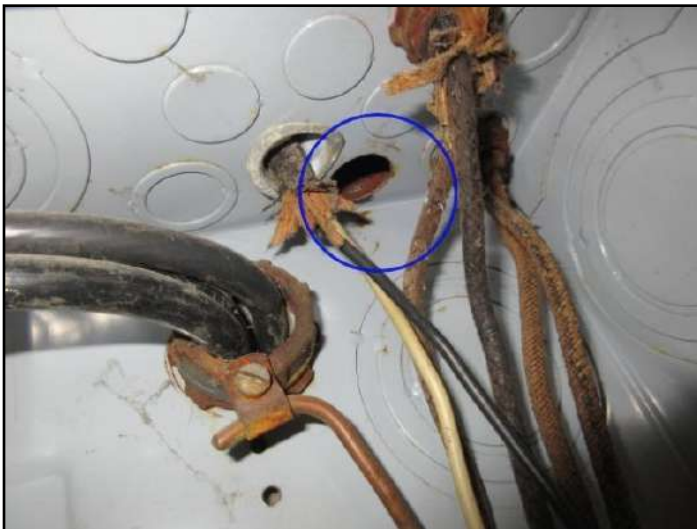
75. Openings in panel

22. Condition: • [Openings in panel](#)

Implication(s): Electric shock | Fire hazard

any exposed panel openings (that would allow access to the inside of the panel) should be fitted with secure covers

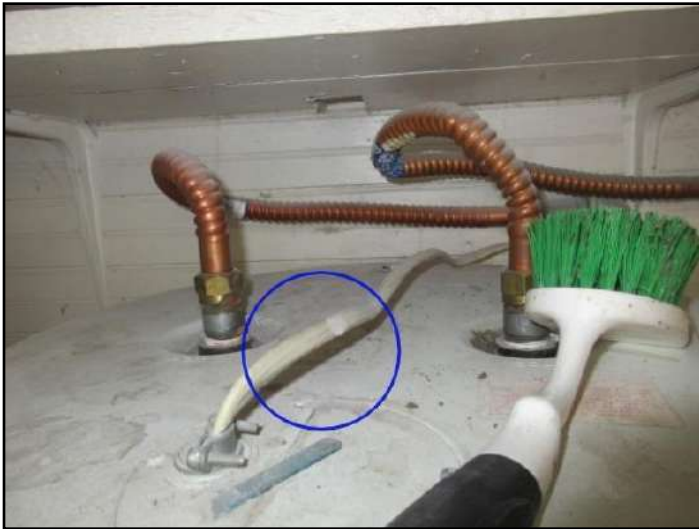
81. Flexible conduit needed

26. Condition: • [Flexible conduit needed](#)

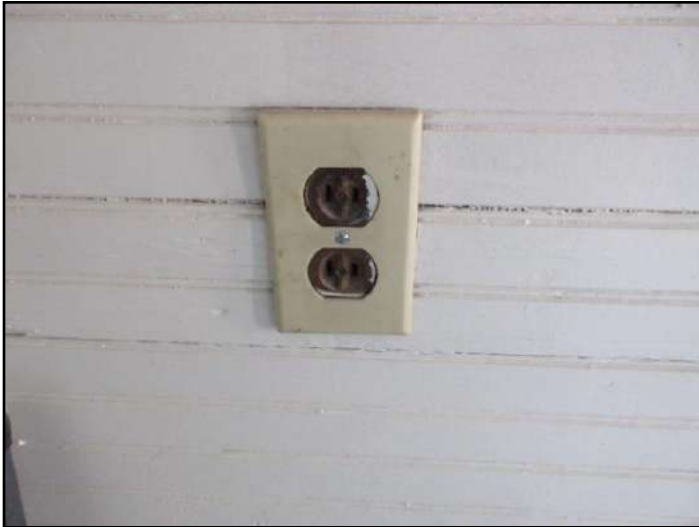
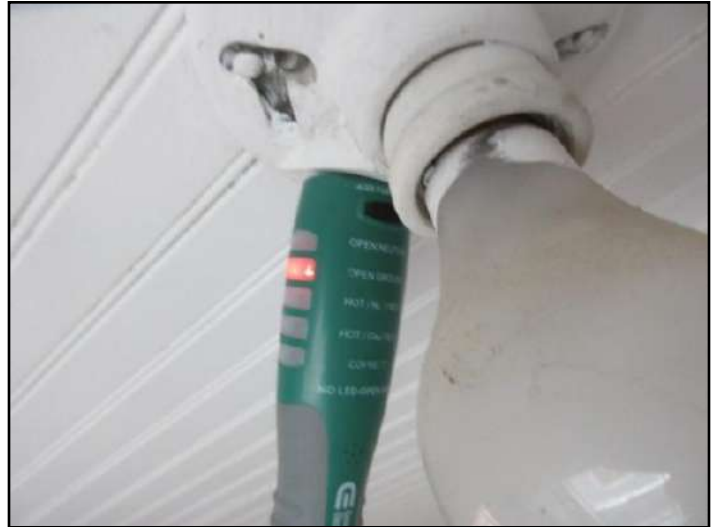
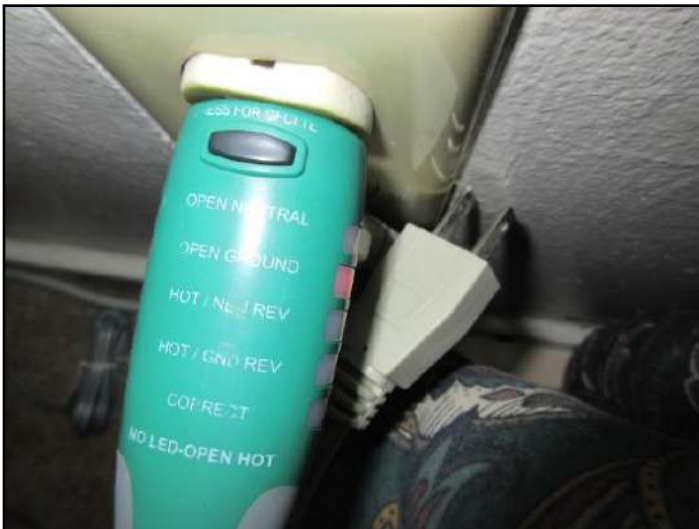
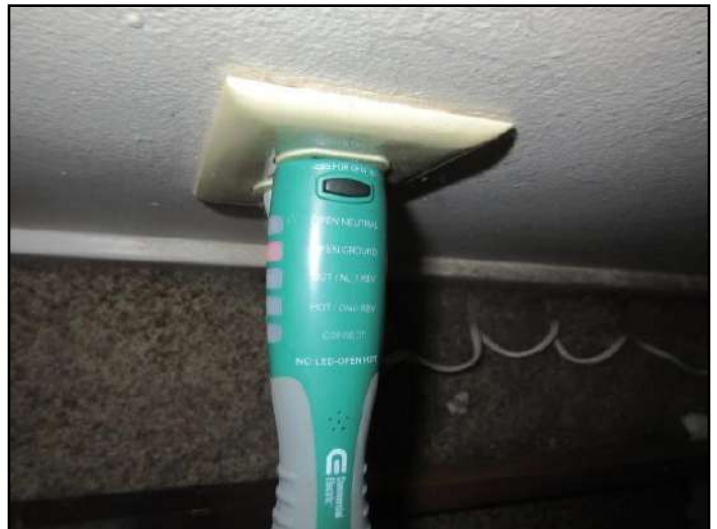
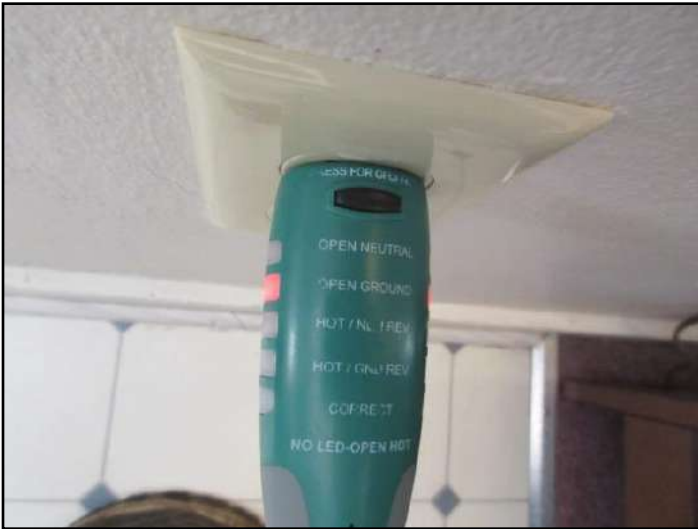
**DISTRIBUTION SYSTEM \ Outlets (receptacles)****27. Condition:** • [Ungrounded](#)**Implication(s):** Electric shock**Location:** Throughout**Task:** Improve

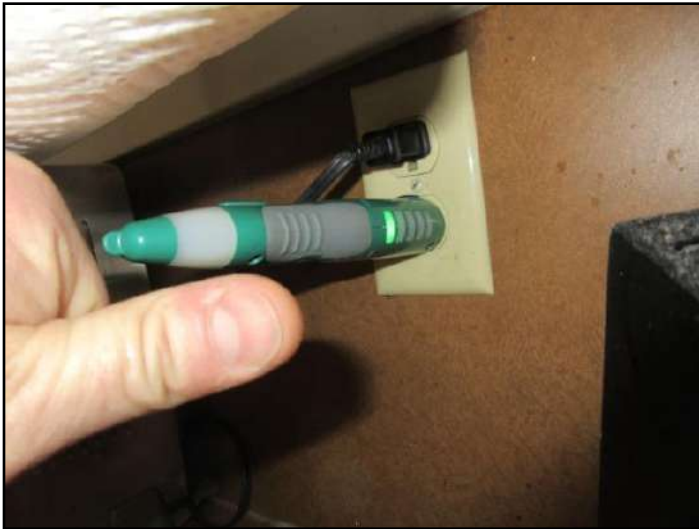
92. No GFCI/GFI (Ground Fault Circuit...

28. Condition: • [No GFCI/GFI \(Ground Fault Circuit Interrupter\)](#)

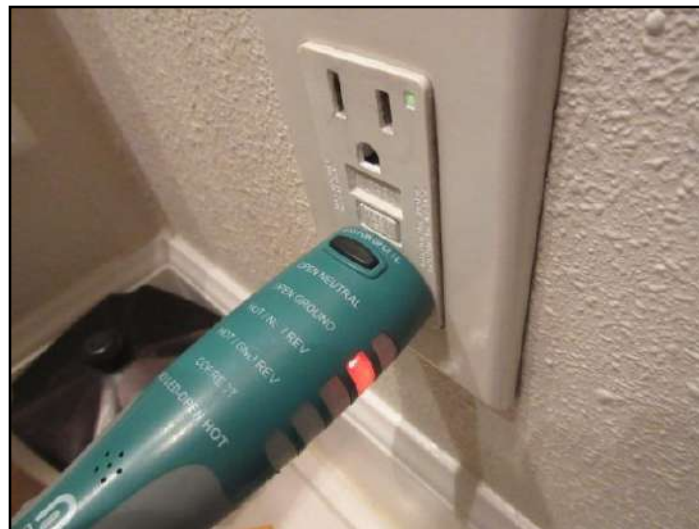
94. Test faulty on GFCI/GFI (Ground Fault...

29. Condition: • [Test faulty on GFCI/GFI \(Ground Fault Circuit Interrupter\)](#)

Location: Bathroom

Task: Further evaluation

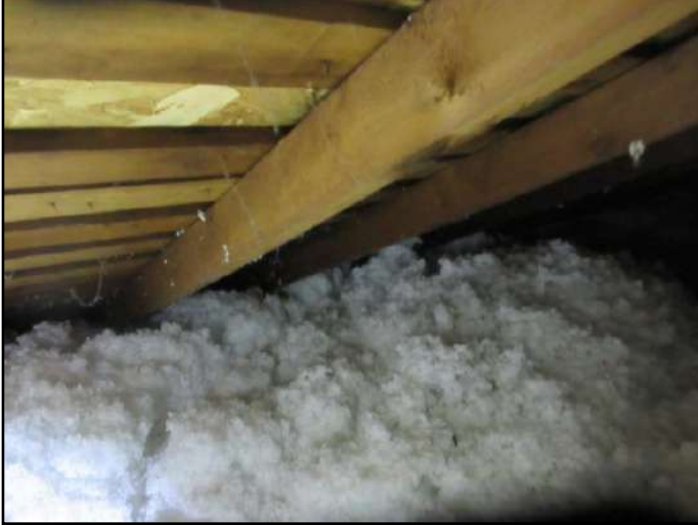
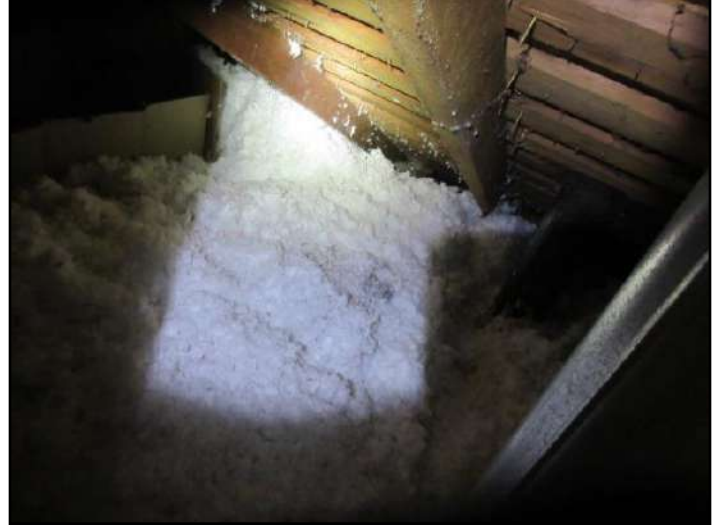
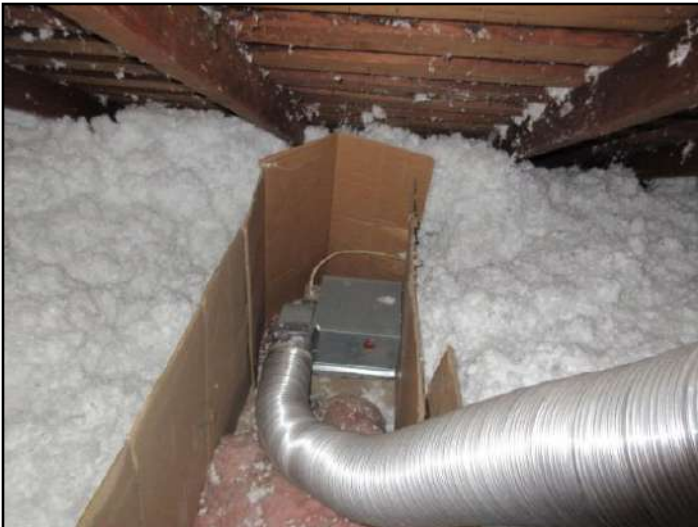
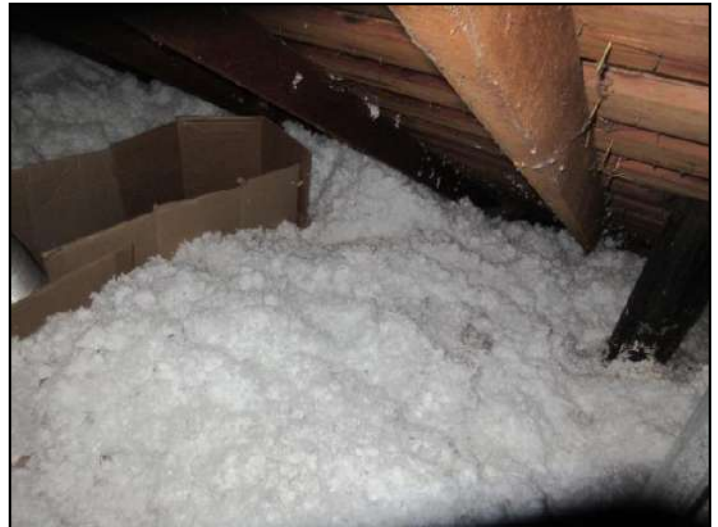
- [Glass fiber](#)
- [Mineral wool \(rock wool\)](#)

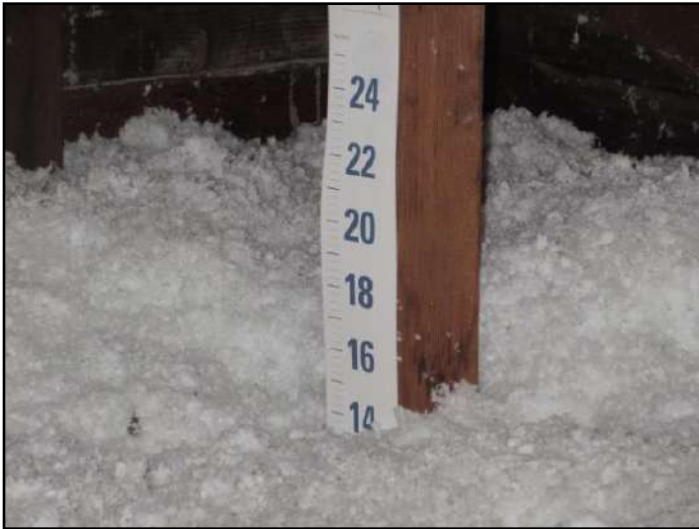
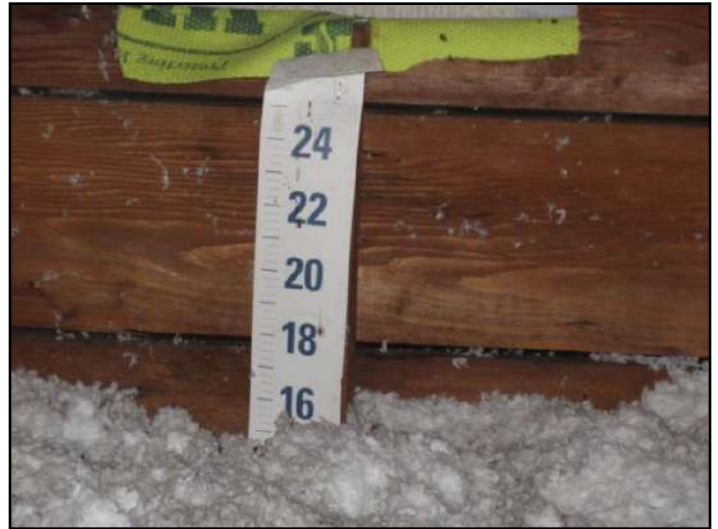
### Attic/roof insulation amount/value:

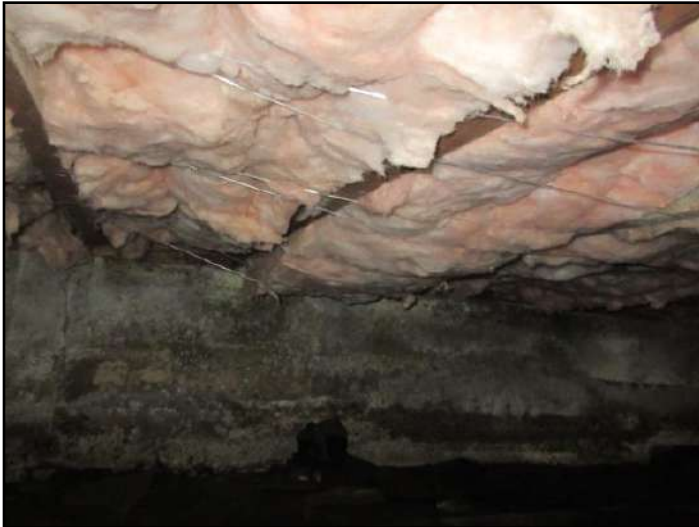
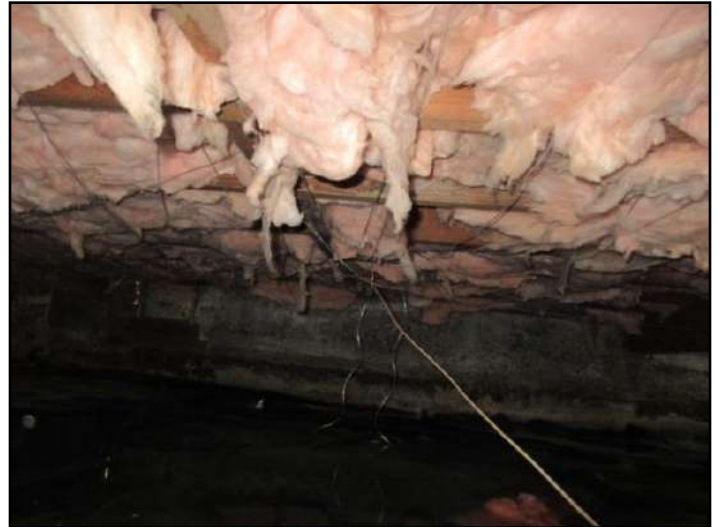
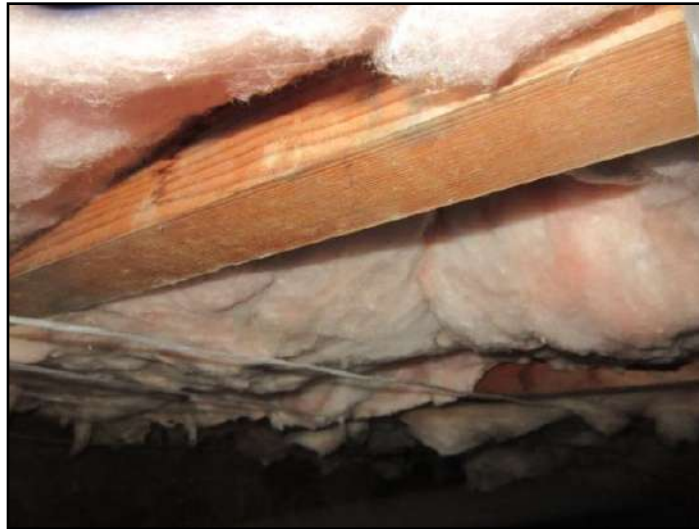
• [Glass fiber](#)

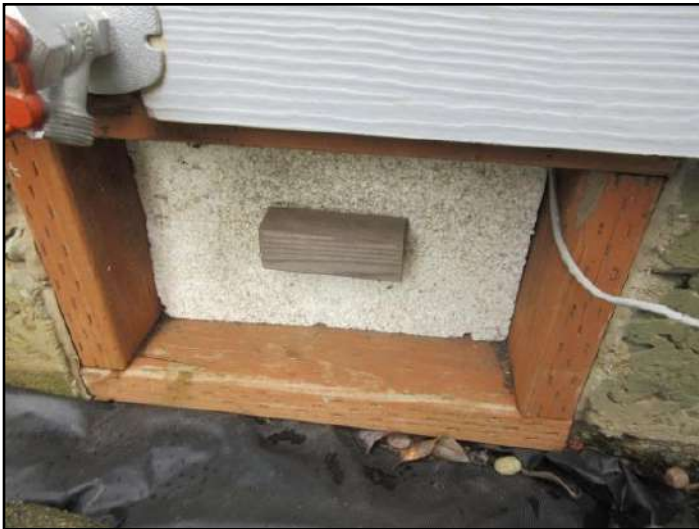
107. Obstructed

**32. Condition:** • Obstructed

**Implication(s):** Chance of condensation damage to finishes and/or structure

**Location:** Throughout Exterior

**Task:** Correct

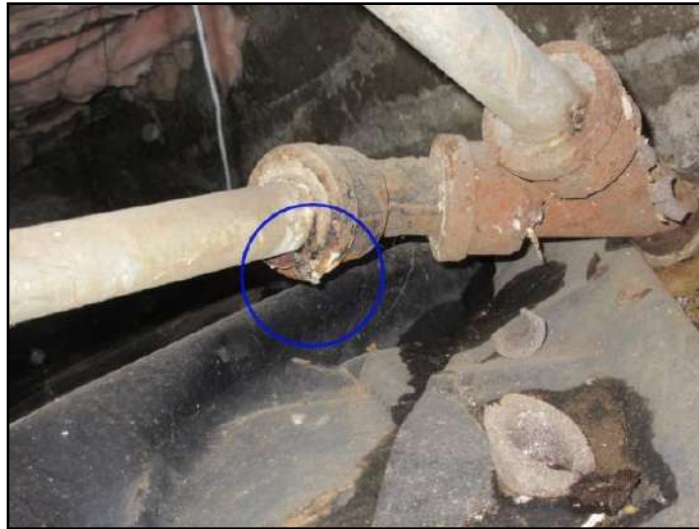
119. Signs of seepage, but was unable to confirm...

**36. Condition:** • Signs of seepage, but was unable to confirm at the time of inspection

**Location:** Crawl Space

**Task:** Monitor

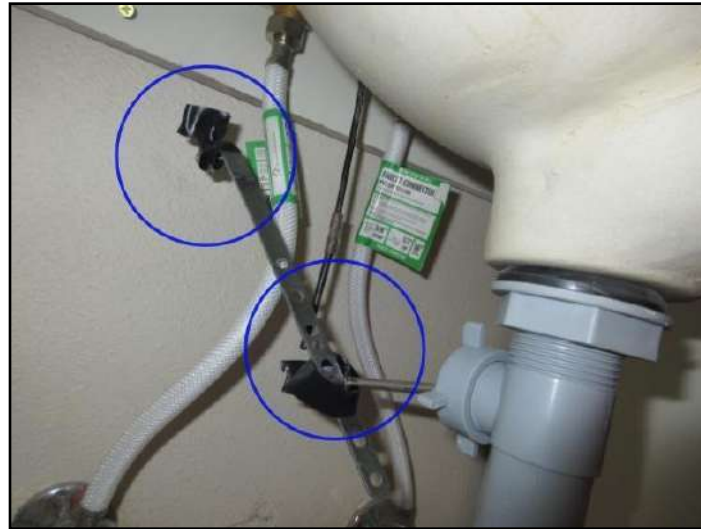
124. Drain stop ineffective

39. Condition: • Drain stop ineffective

Location: Bathroom

Task: Improve

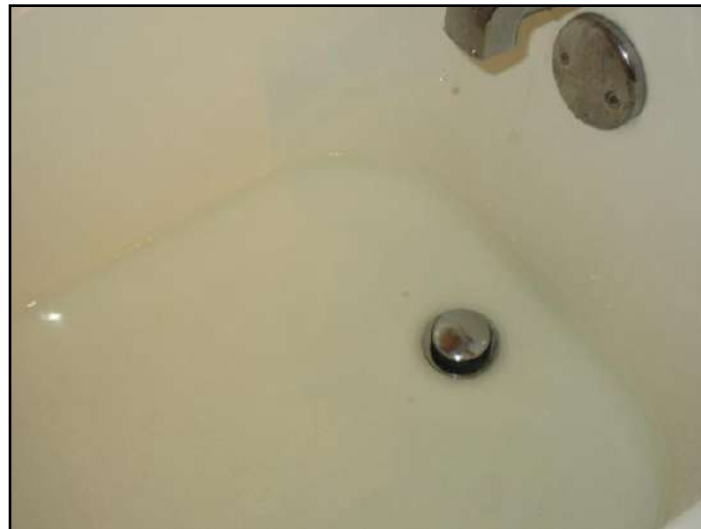
125. Slow drain

40. Condition: • [Slow drain](#)

Implication(s): Chance of water damage to contents, finishes and/or structure

Location: Bathroom

Task: Improve

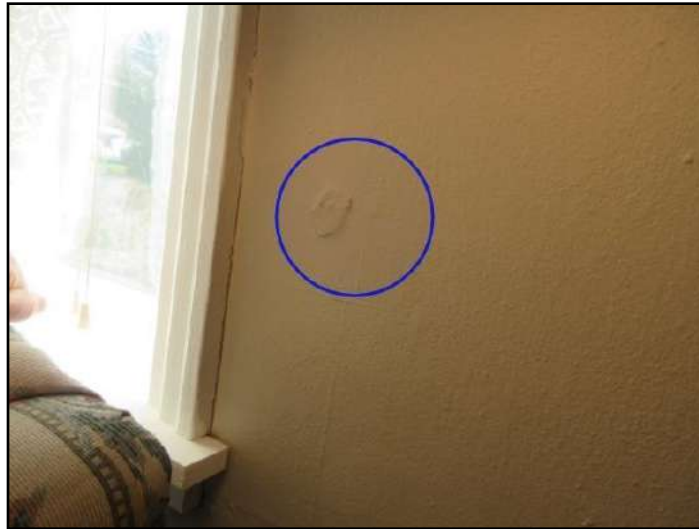
137. Nail pops

44. Condition: • [Nail pops](#)

Location: West Living Room

Task: Monitor

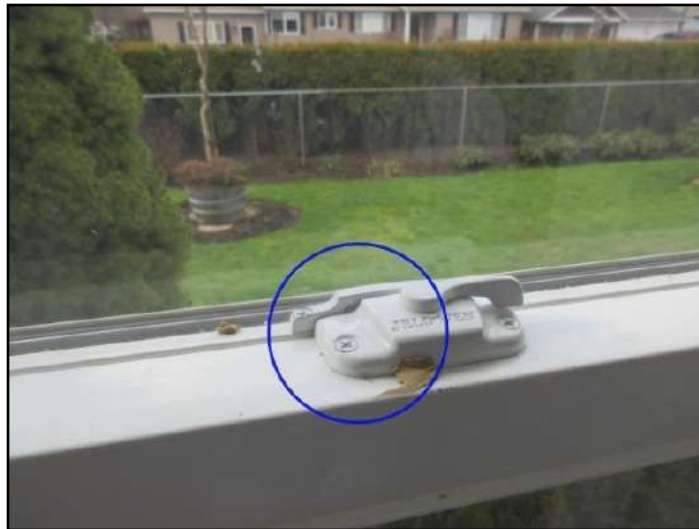
138. Adjustment needed

**45. Condition:** • Adjustment needed

**Location:** Northeast Bedroom

**Task:** Improve

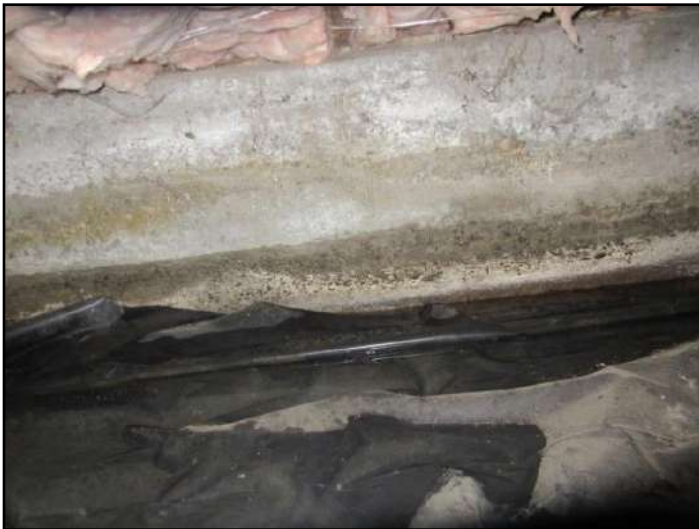
140. Water marks

47. Condition: • [Water marks](#)

Implication(s): Chance of water damage to contents, finishes and/or structure

Location: Throughout Crawl Space

Task: Monitor

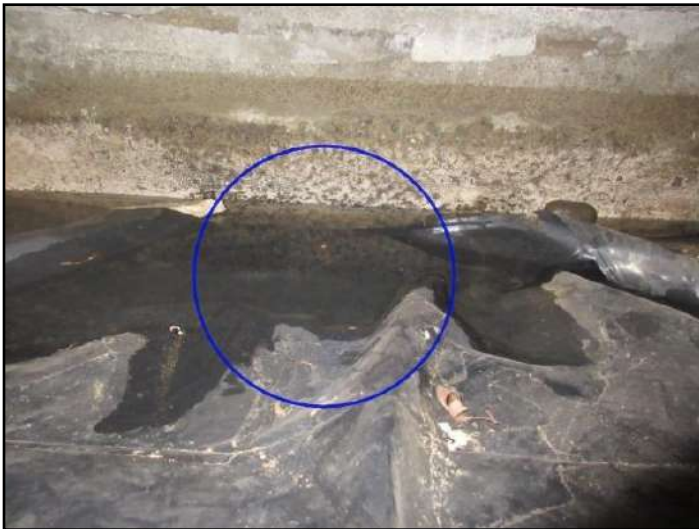
144. Water on floor

**48. Condition:** • [Water on floor](#)

**Implication(s):** Chance of water damage to contents, finishes and/or structure

**Location:** Throughout Crawl Space

**Task:** Further evaluation

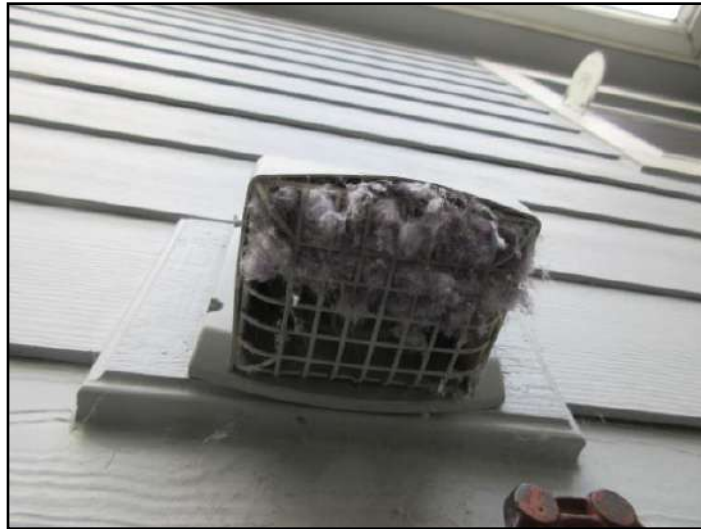
150. Screen on vent termination

49. Condition: • Screen on vent termination

Implication(s): Chance of condensation damage to finishes and/or structure | Equipment ineffective | Fire hazard

Location: East Exterior

Task: Correct
